Facts and findings on the 2021 floods in Limburg (NL)

Nathalie Asselman

23 June 2022

Watersystem evaluation

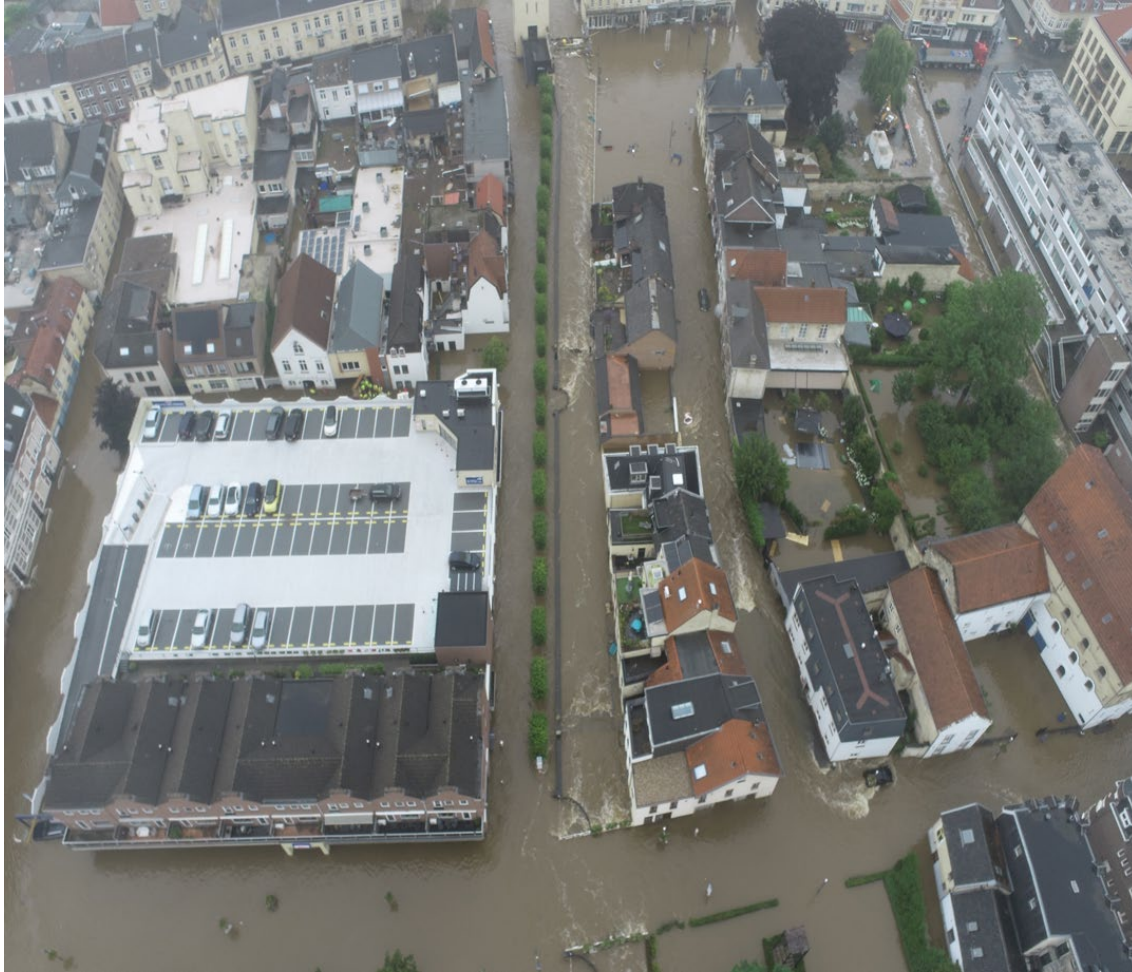
Flooding in Valkenburg

Water depths at many locations about 1,25 m

High flow velocities in some streets

Damage to buildings and bridges

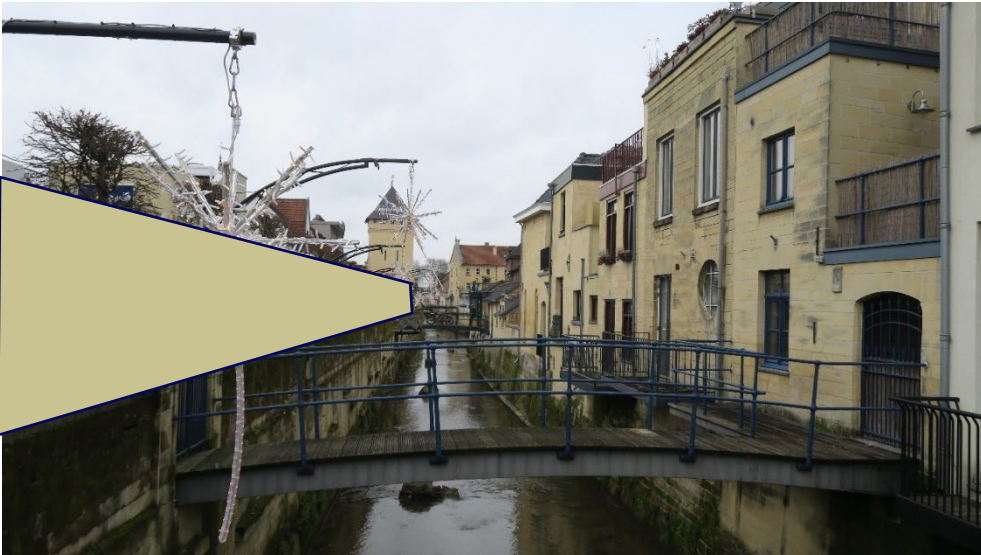
Flooding in Valkenburg – possible measures

3 m high in city centre, starting 2.5 km upstream
Problems with foundation, bridges and existing buildings

Embankments:

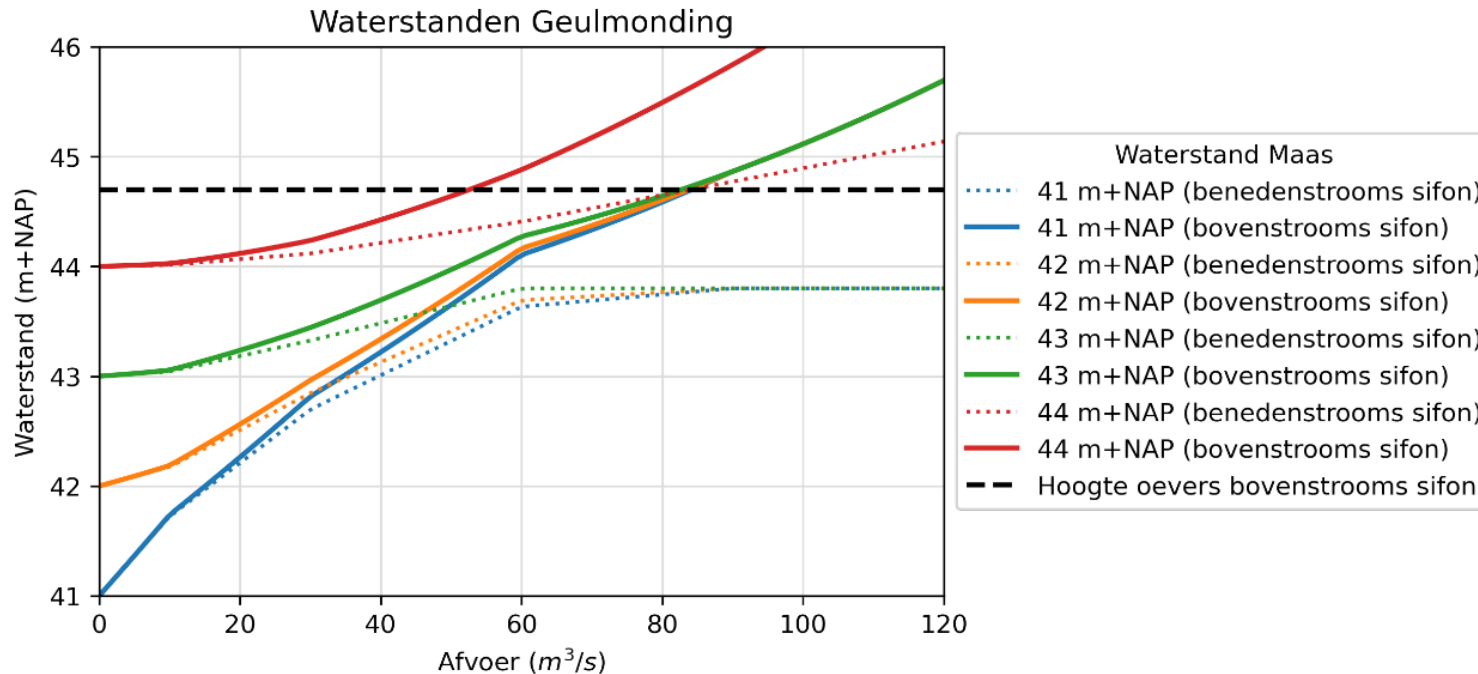
Confluence of Geul and Maas

- Peak discharge near Meerssen $\pm 110 \text{ m}^3/\text{s}$
- Capacity culvert low water levels Meuse $\pm 85 \text{ m}^3/\text{s}$
- Capacity culvert July (high water levels Meuse) $\pm 55 \text{ m}^3/\text{s}$
- Capacity may have been reduced further by blockage with driftwood or sediment

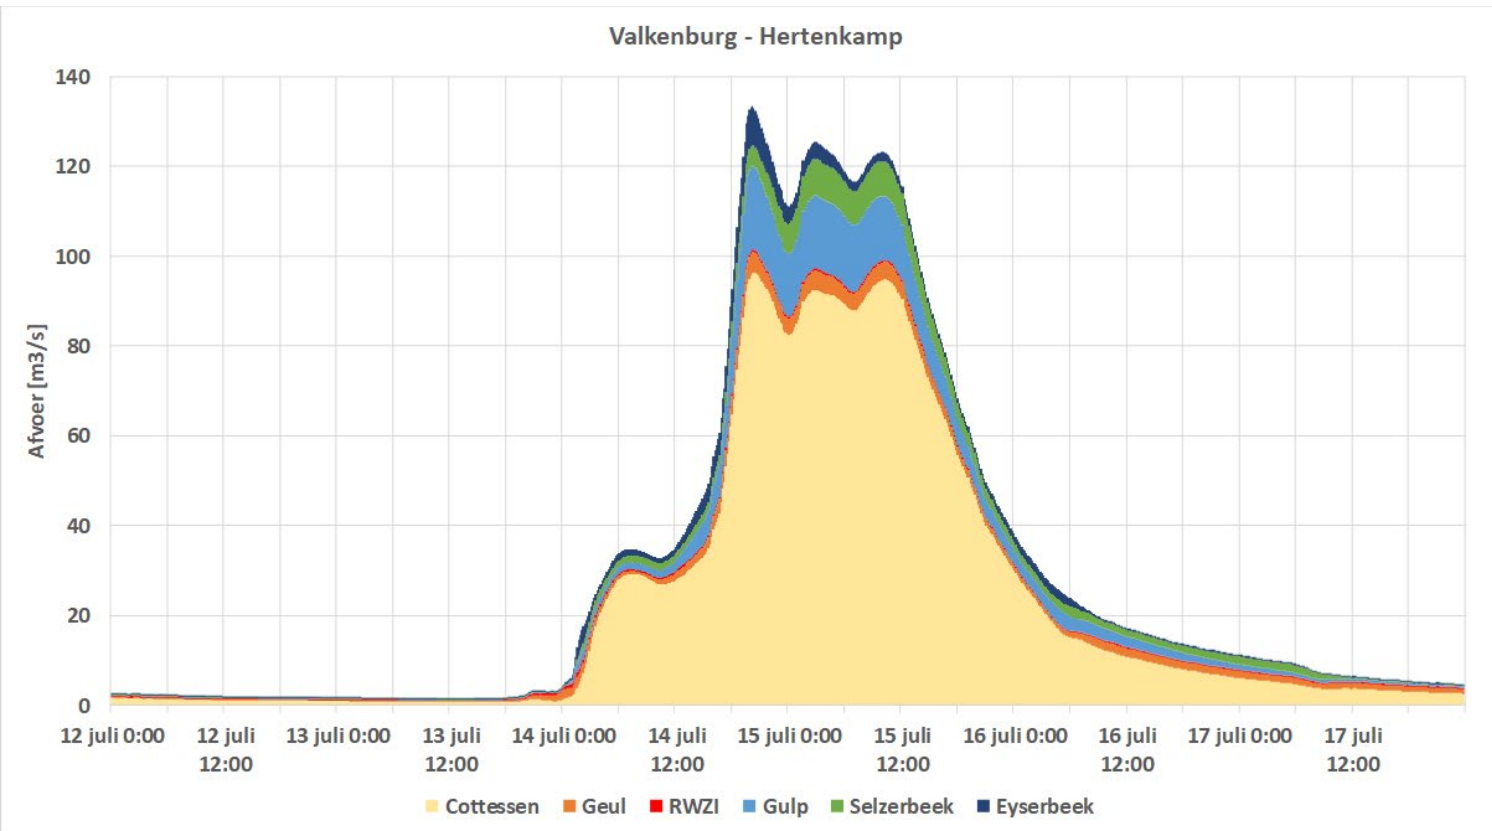
Discharge: 'origin' of the water

- Peak discharge Valkenburg 135 m³/s
- Large contribution (70%) from Belgium

→ development of a cross border FRM plan would be 'ideal'

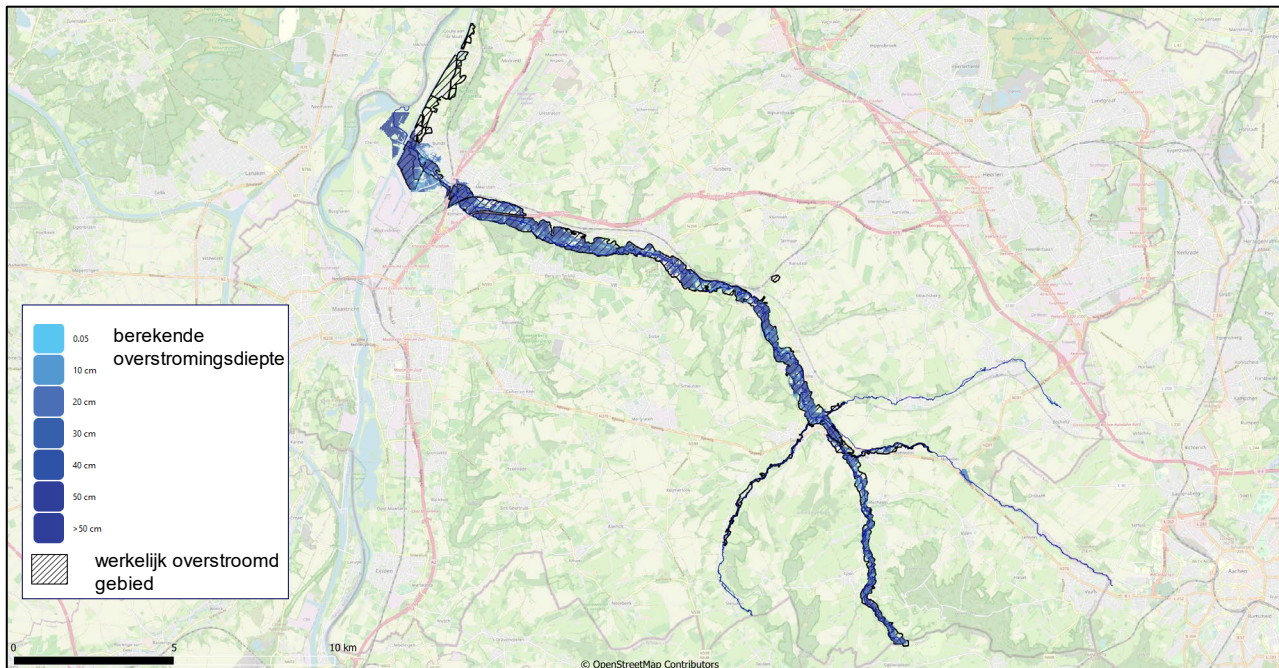
Storage in flood plain: peak attenuation

- Large scale flooding
- Peak discharge near Valkenburg 135 m³/s
- Near Meerssen 110 m³/s (-20%)

→ peak attenuation is important and should be maintained/accounted for in the FRM plan
