Excursion Sheet

Eberle Rockfall and Talfer Slit Dam

Date: May 2nd 2023

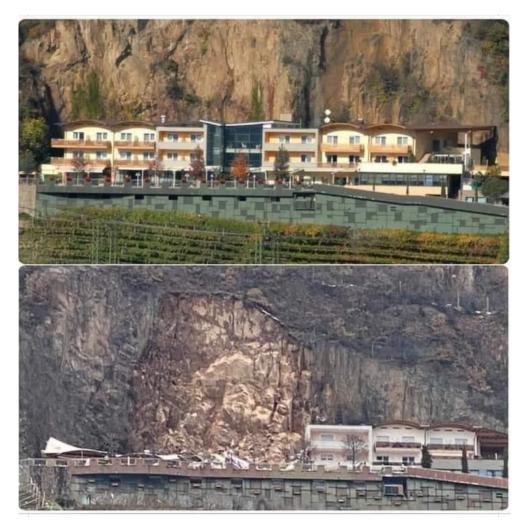
Figure 2.1: Eberle Rockfall occurred Jan 5th 2021

On January 5th 2021 a large rockfall detached from the porphyry rock wall above the Eberle hotel in Bozen. Luckily the hotel was closed due to the pandemic (Covid19). The hotel is located beneath the walls of Hörtenberg, about 70 m above the town, along the Sant'Osvaldo panoramic walkway. The volume of the rockfall was approximately 3500 m³; it was 25m high and 20 m large. Figure 2.1 shows a comparison of the building before and after the rockfall.

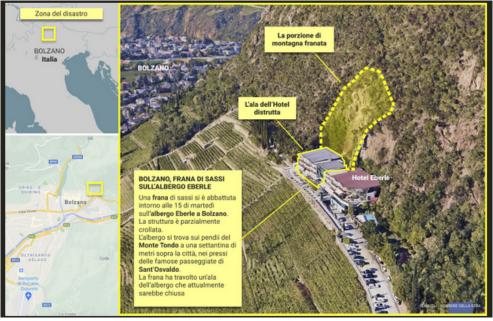
Figure 2.2: Eberle Rockfall: to the left the part of the hotel that was partially destroyed

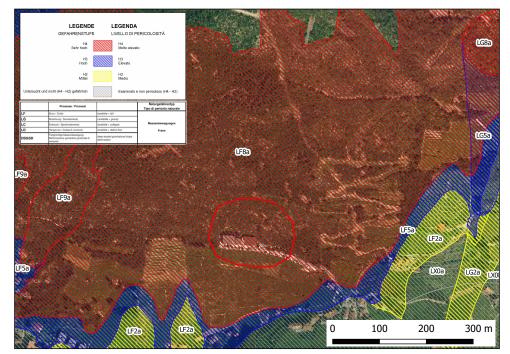
Figure 2.3: Eberle Rockfall: hazard map

The Geological office of the Province of Bozen carried out detailed analysis to investigate the current rockfall hazard to design appropriate mitigation measures. Details will be provided by the Director of the Geological office during the excursion.

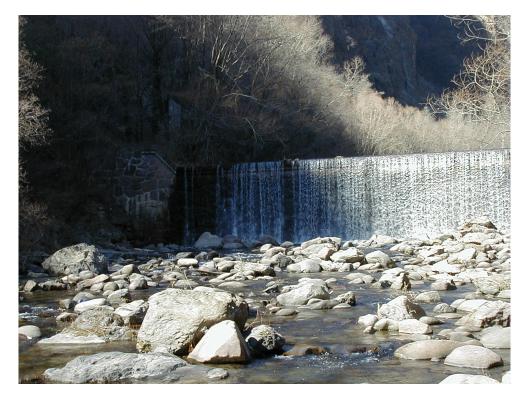
Figure 3.1: The old retention dam North of Bolzano

The Talferbach had threatened Bozen for a long time until a large retention dam was built North of town (Figure 1.2). This dam trapped sediments and large amounts of wood; in addition it was an obstacle for the fish. Downstream the retention dam 45 check dams and lateral walls confined the river to an artificial morphology to protect Bozen from flooding. Lately a change in culture and mentality has enhanced the values of river ecology and its related ecosystem services. Starting from 2015 a series of river restoration measures has been implemented by the civil Protection Agency of the Province of Bozen. Some of the 45 check dams have been opened in order to promote fish and sediment continuity. An analysis carried out by comparing Lidar surveys taken in 2013 and 2016 proved the effectiveness of the check dam opening. Figure 3.7 shows pattern of scour (red) along the alternate flow direction and aggradation (blue) elsewhere. In 2018 the old retention dam (Figure 3.1) was substituted with a new one, which is more permeable to sediments and wood in case of small and frequent flood events. This dam is characterized by a filter, made of a series of steel beams (Figures 3.2 and 3.3), which is able to capture a large amount of wood and sediments during high flood events.

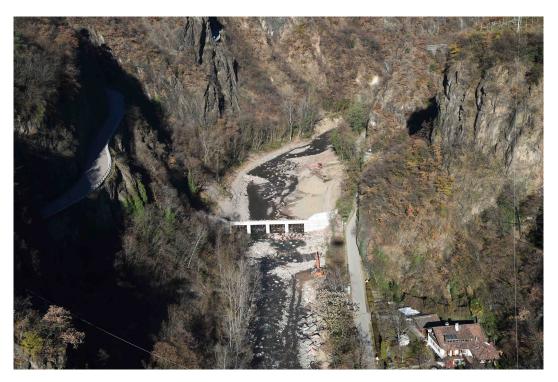
Figure 3.2: The new slit dam built in 2018 - view toward North

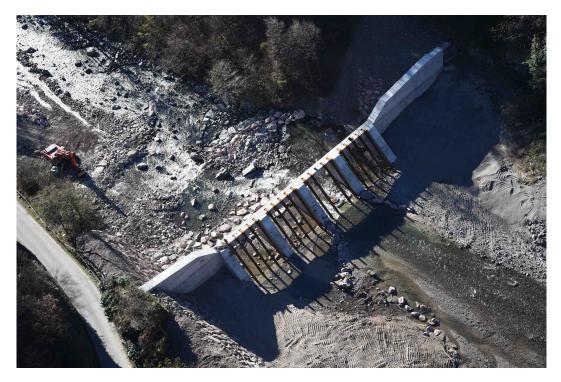
Figure 3.3: The new slit dam built in 2018 - the steel filter

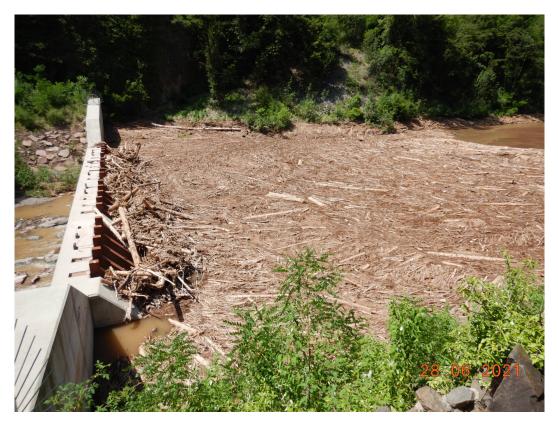
Figure 3.4: The new slit dam during the event of June 2021

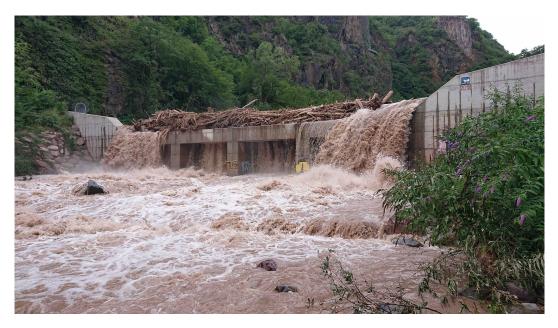
Figure 3.5: The new slit dam during the August 2021 event

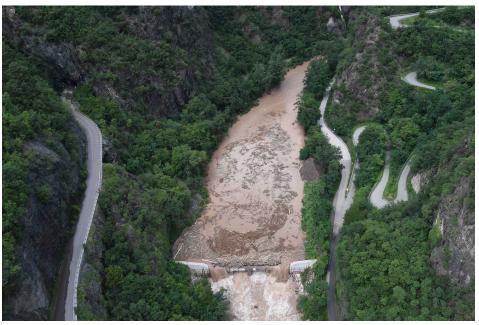
Figure 3.6: The new slit dam during the August 2021 event

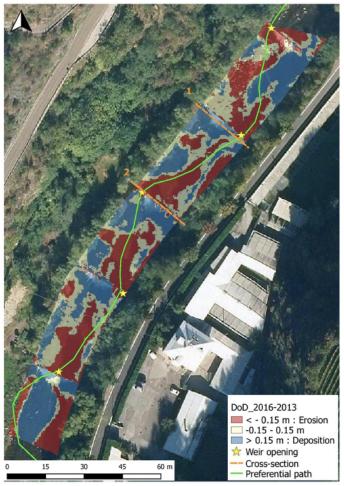
Figure 3.7: DEM of Difference: Lidar2016 - Lidar2013

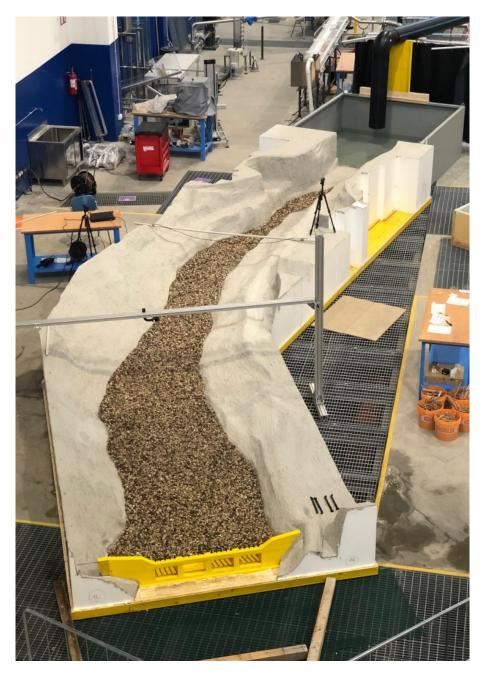
Figure 3.8: Physical model constructed by the University of Bozen (Prof. M. Righetti)

With the purpose of optimising the selectivity of the slit dam with respect to its ability to retain sediments and wood, a physical model has been implemented by the University of Bozen in its hydraulic Lab (Figures 3.8 and 3.9). Experiments show that the time distribution of wood within the flow has an impact on the retention capability of the slit dam; indeed, the more lumped the wood amount, the larger the volume of wood trapped behind the dam. Observations show that sediments have an impact on the wood dynamics only if they anticipate the wood wave, and form deposits that can interfere with the wood dynamics, either by filling the space behind the dam or by deviating the logs.

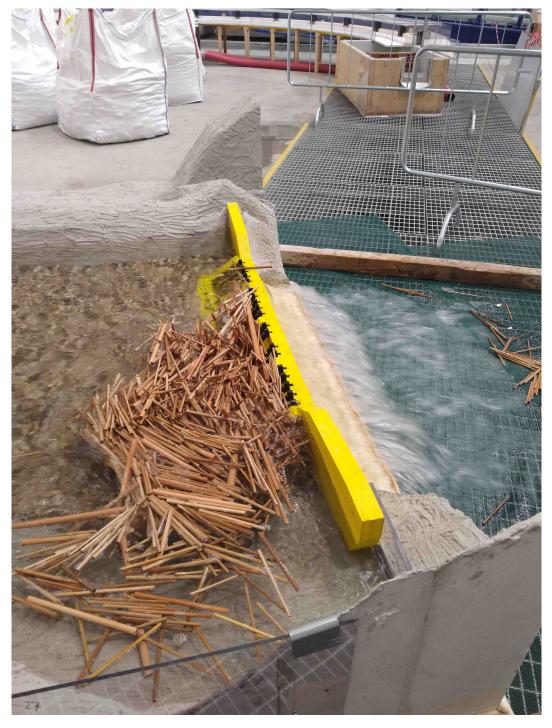
Figure 3.9: Physical model constructed by the University of Bozen (Prof. M. Righetti)
