Sediment transport along the Talferbach

the effectiveness of check dam openings in sediment continuity

Silvia Simoni - Mountain-eering S.r.l.

9th General Assembly - Bolzano May 2nd 2023

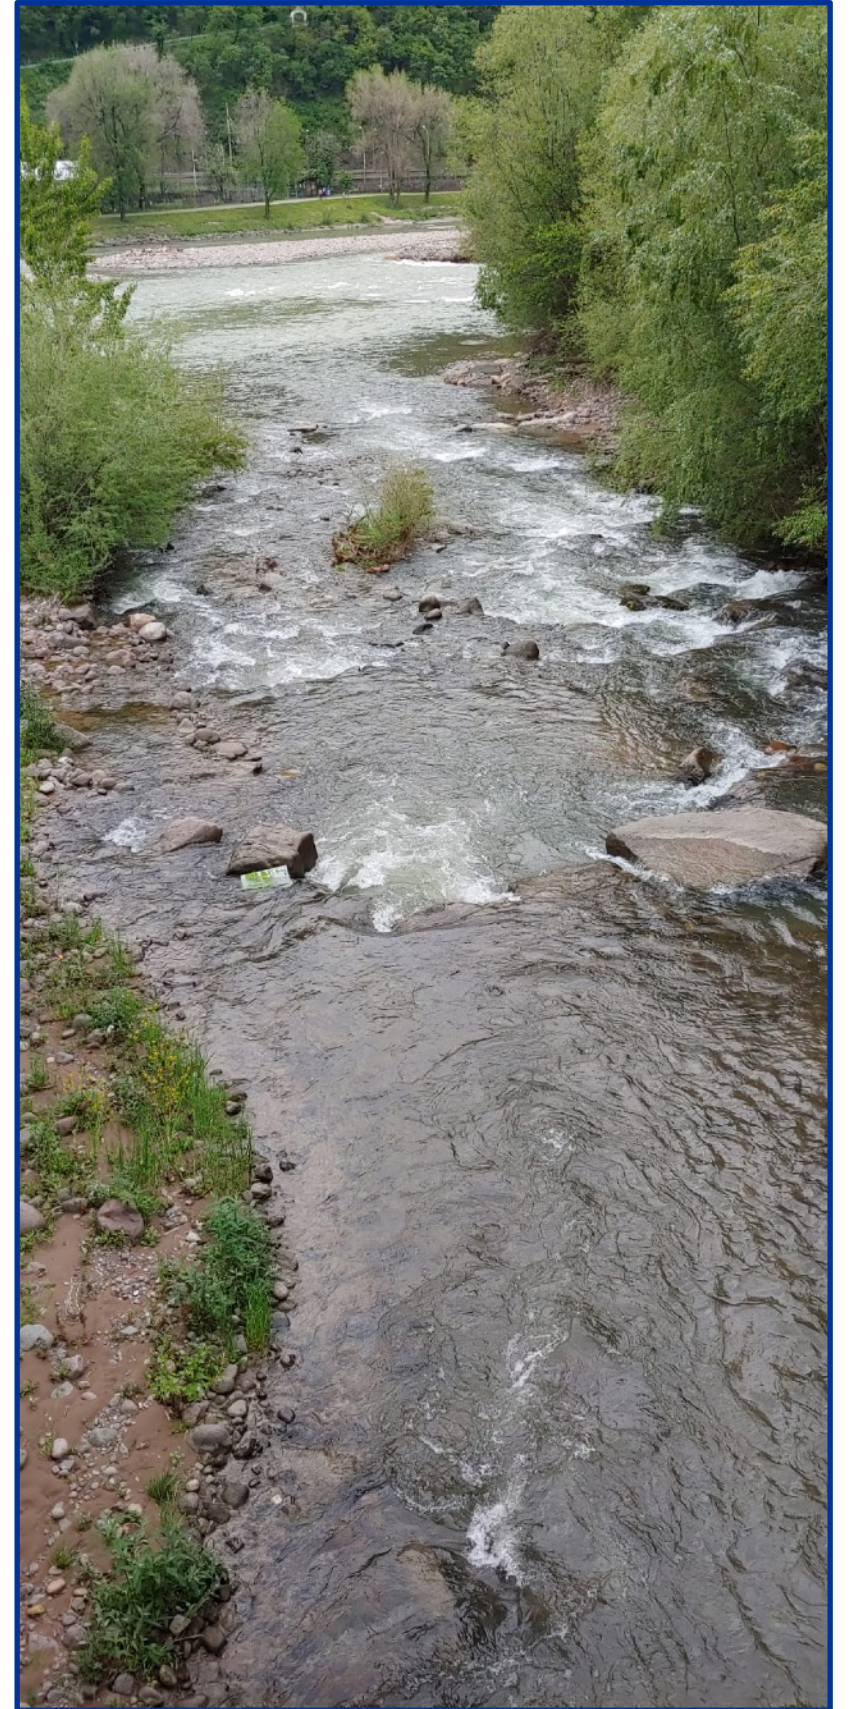
The Talfer-Talvera had threatened Bolzano for a long time until a large retention dam was built North of town

This dam trapped sediments and large amounts of wood; in addition it was an obstacle for the fish. Downstream the retention dam 45 check dams and lateral walls confined the river to an artificial morphology to protect Bozen from flooding.

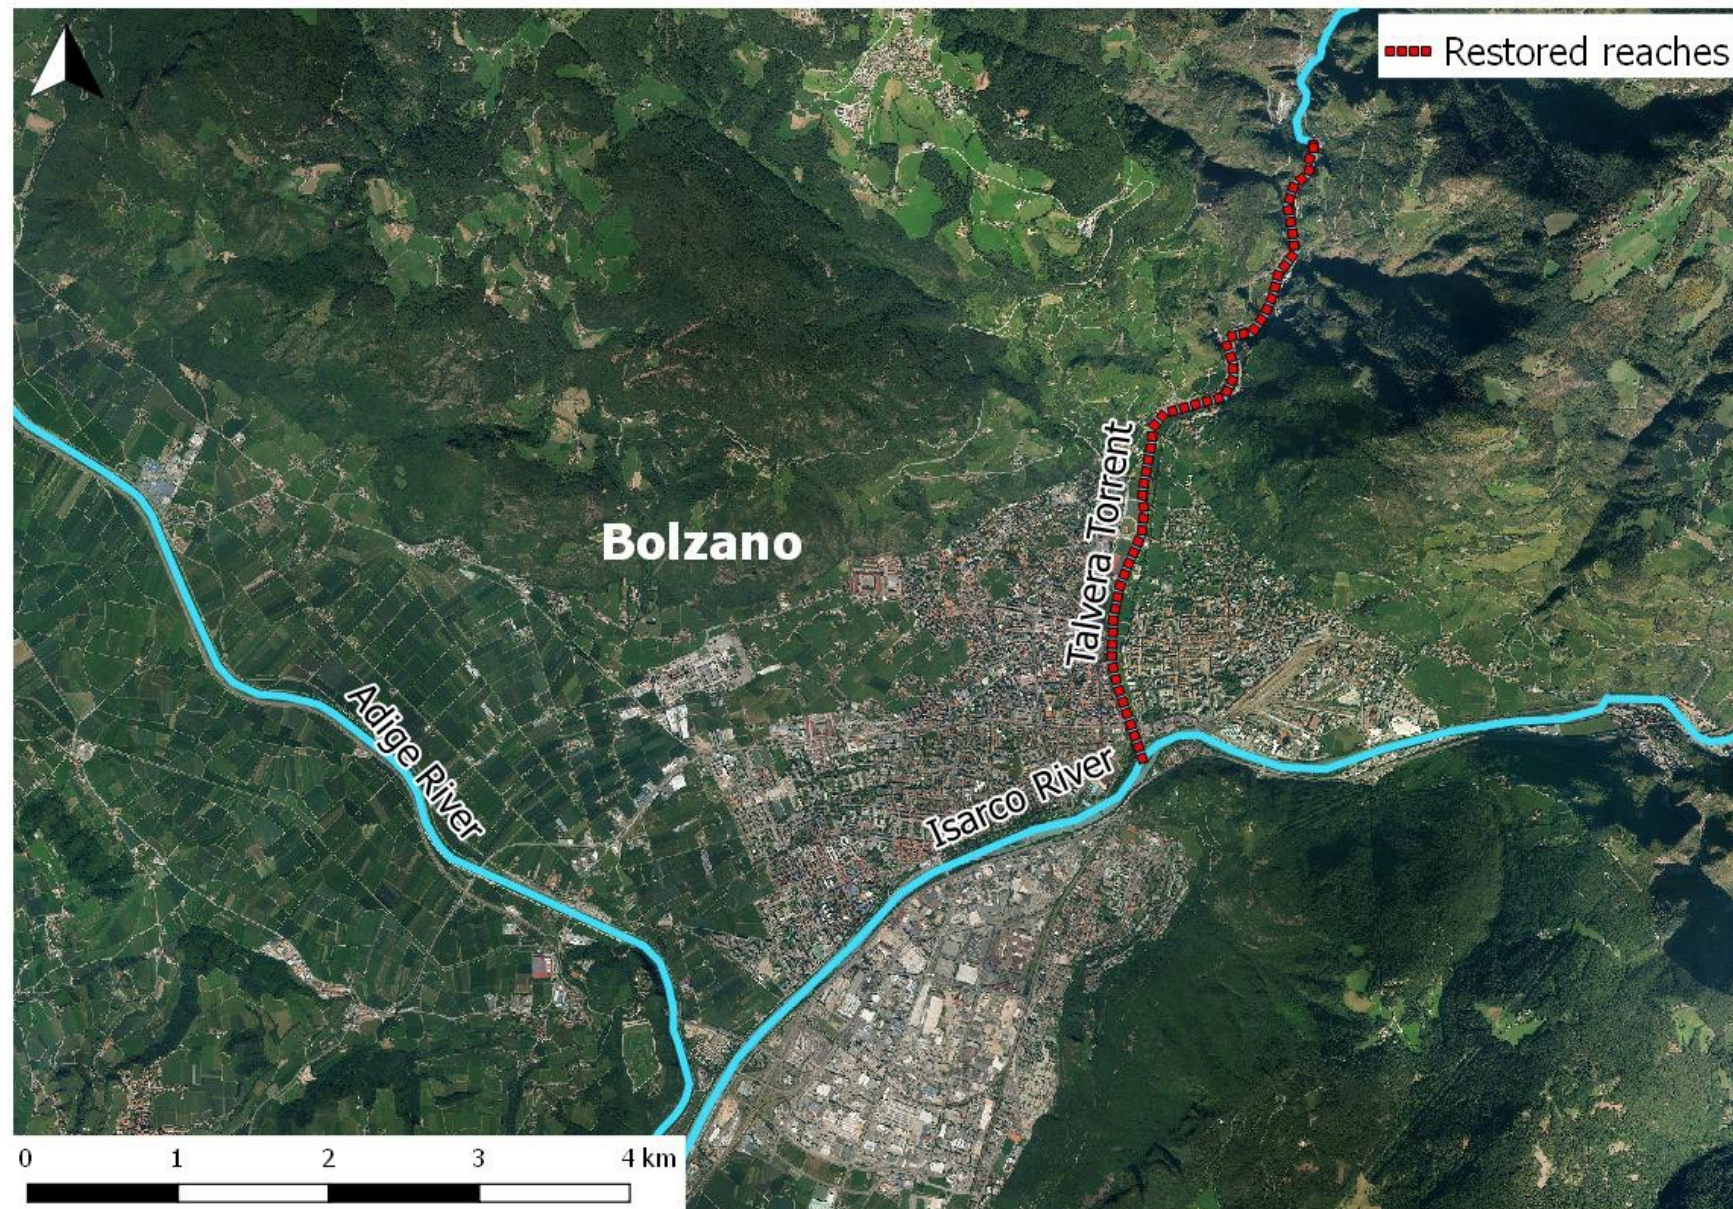
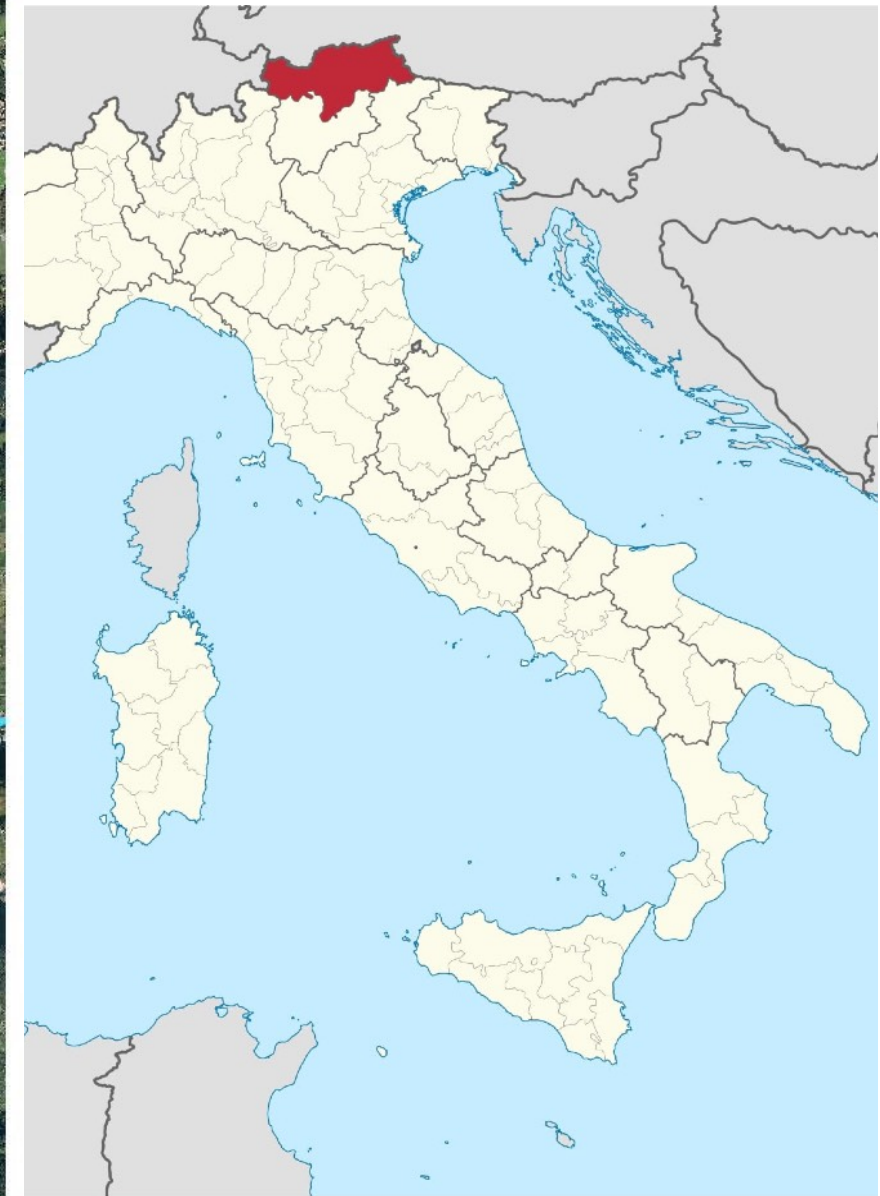
Talferbach - restored reach

Starting from 2015 a series of **River Restoration measures** has been implemented by the civil Protection Agency of the Province of Bozen. Some of the 45 check dams have been opened in order to promote fish and sediment continuity.

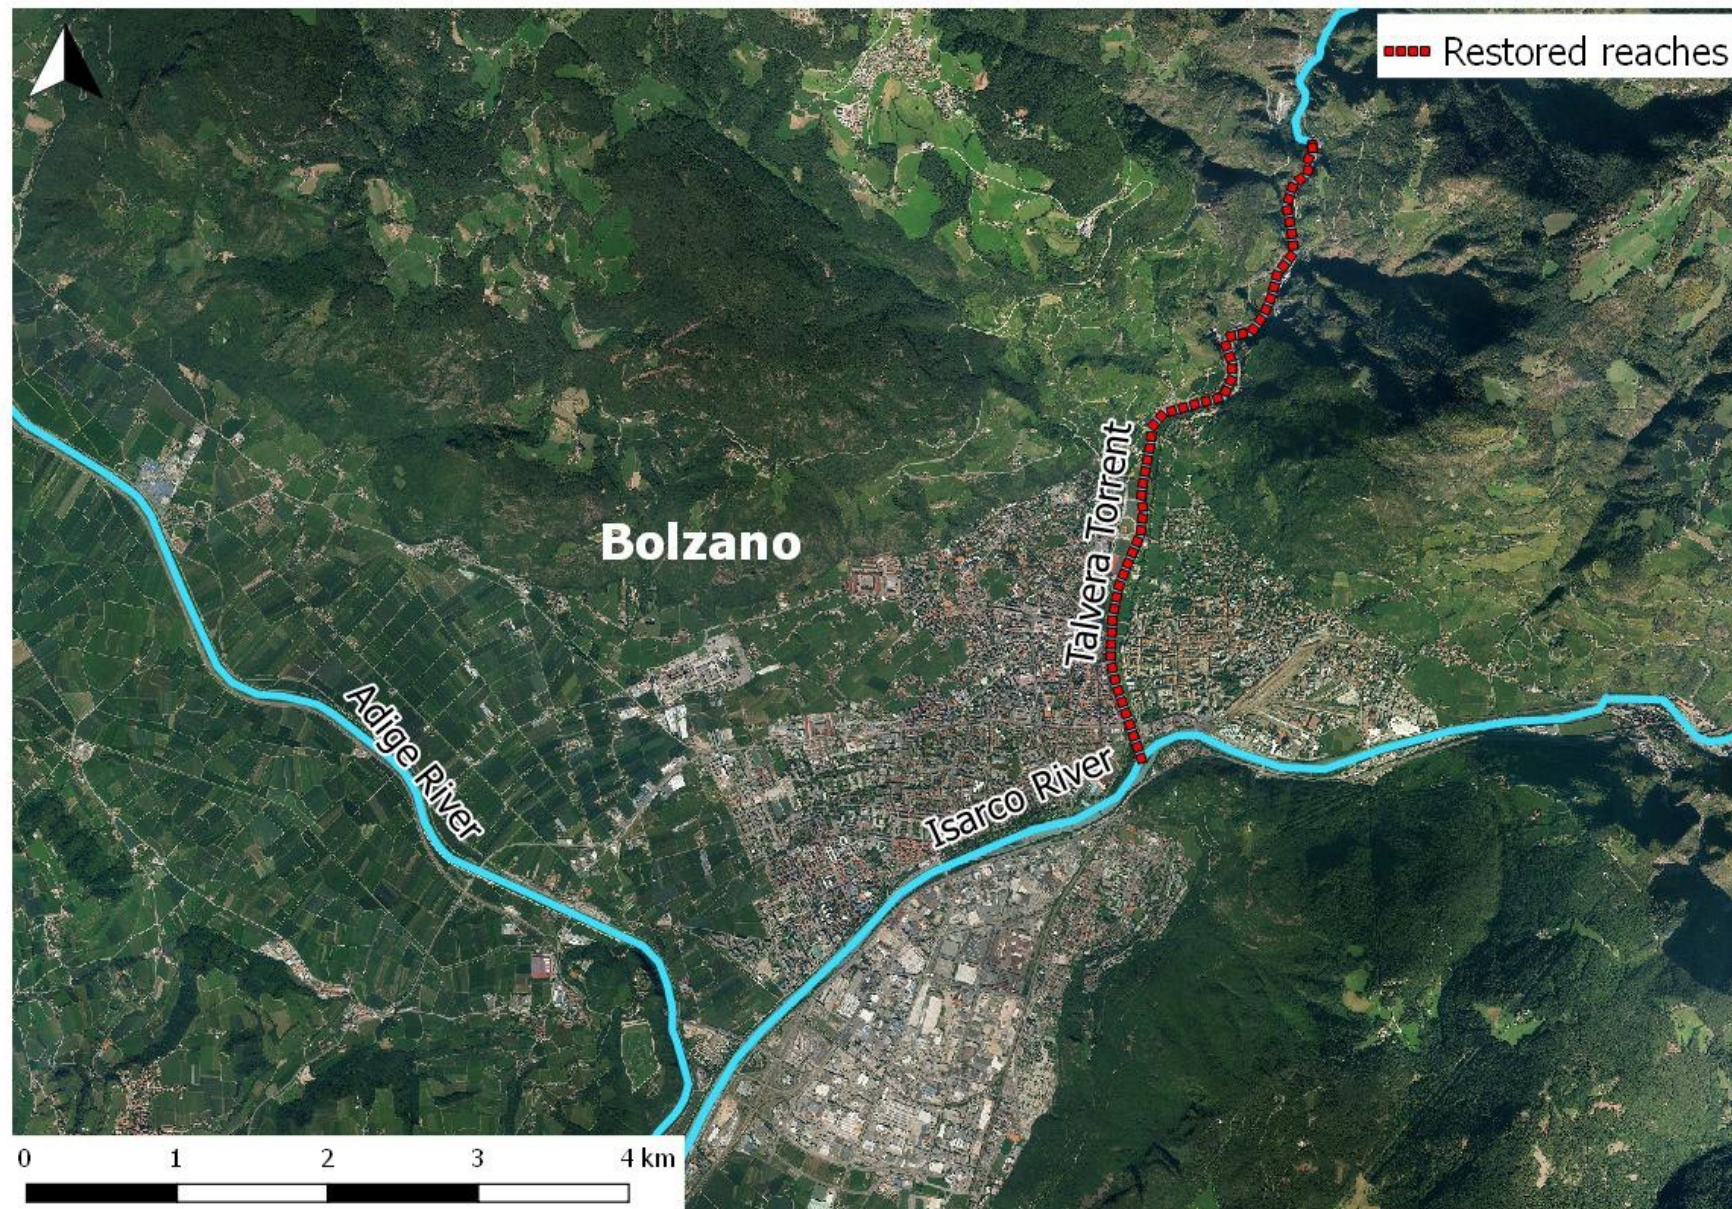
Watercourse	Talvera Torrent
Catchment area	429 km ²
Restored reach length	5 km
Channel slope	2% average
Active channel width	20 – 50 m
Restoration start	2015
Restoration end	2019

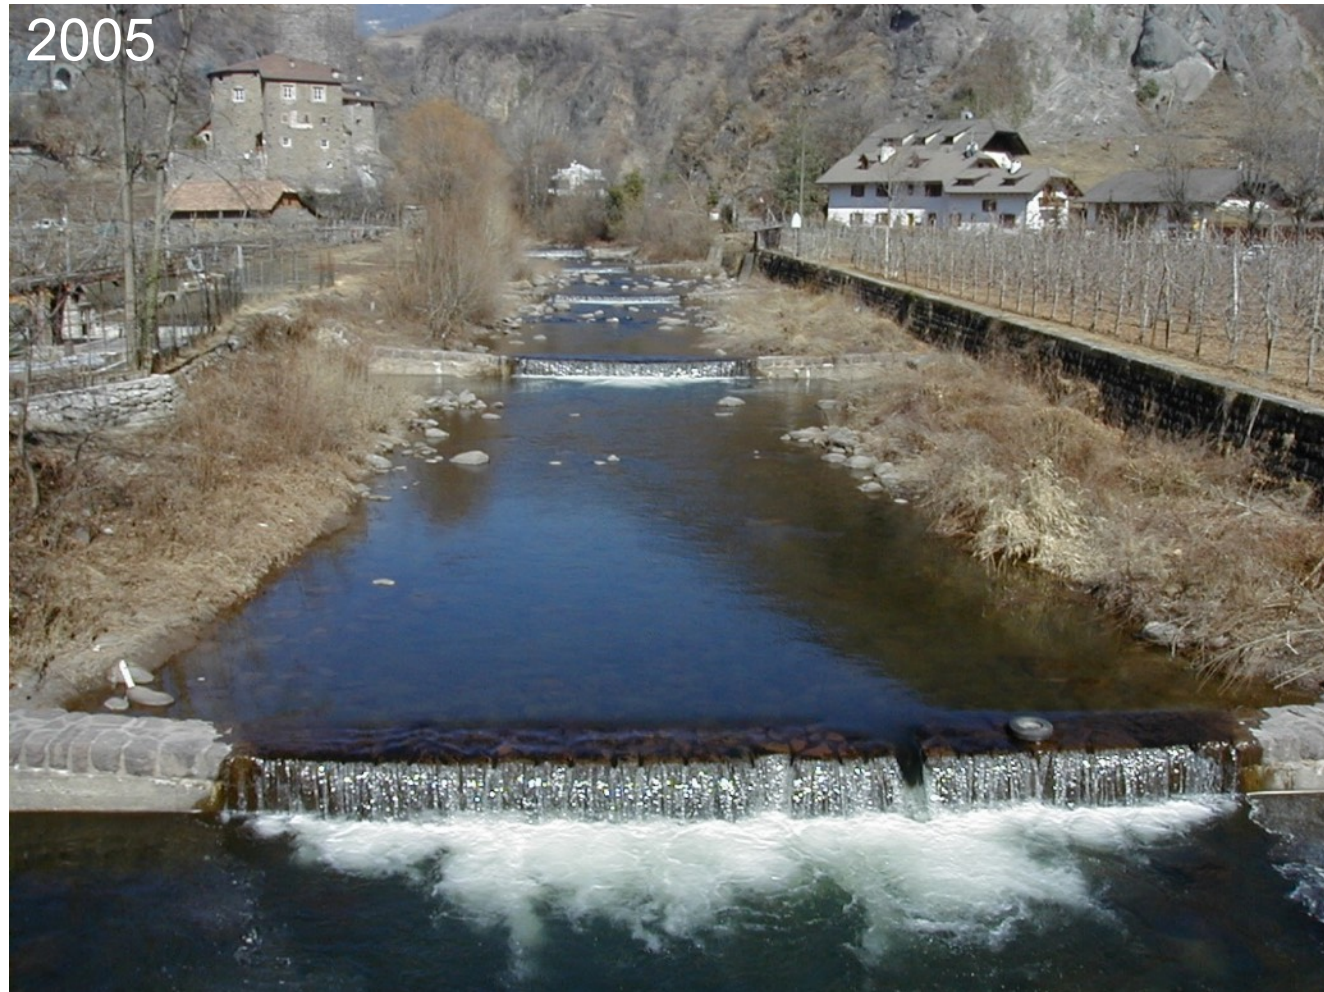
2005

Check dam opening and retention dam removal

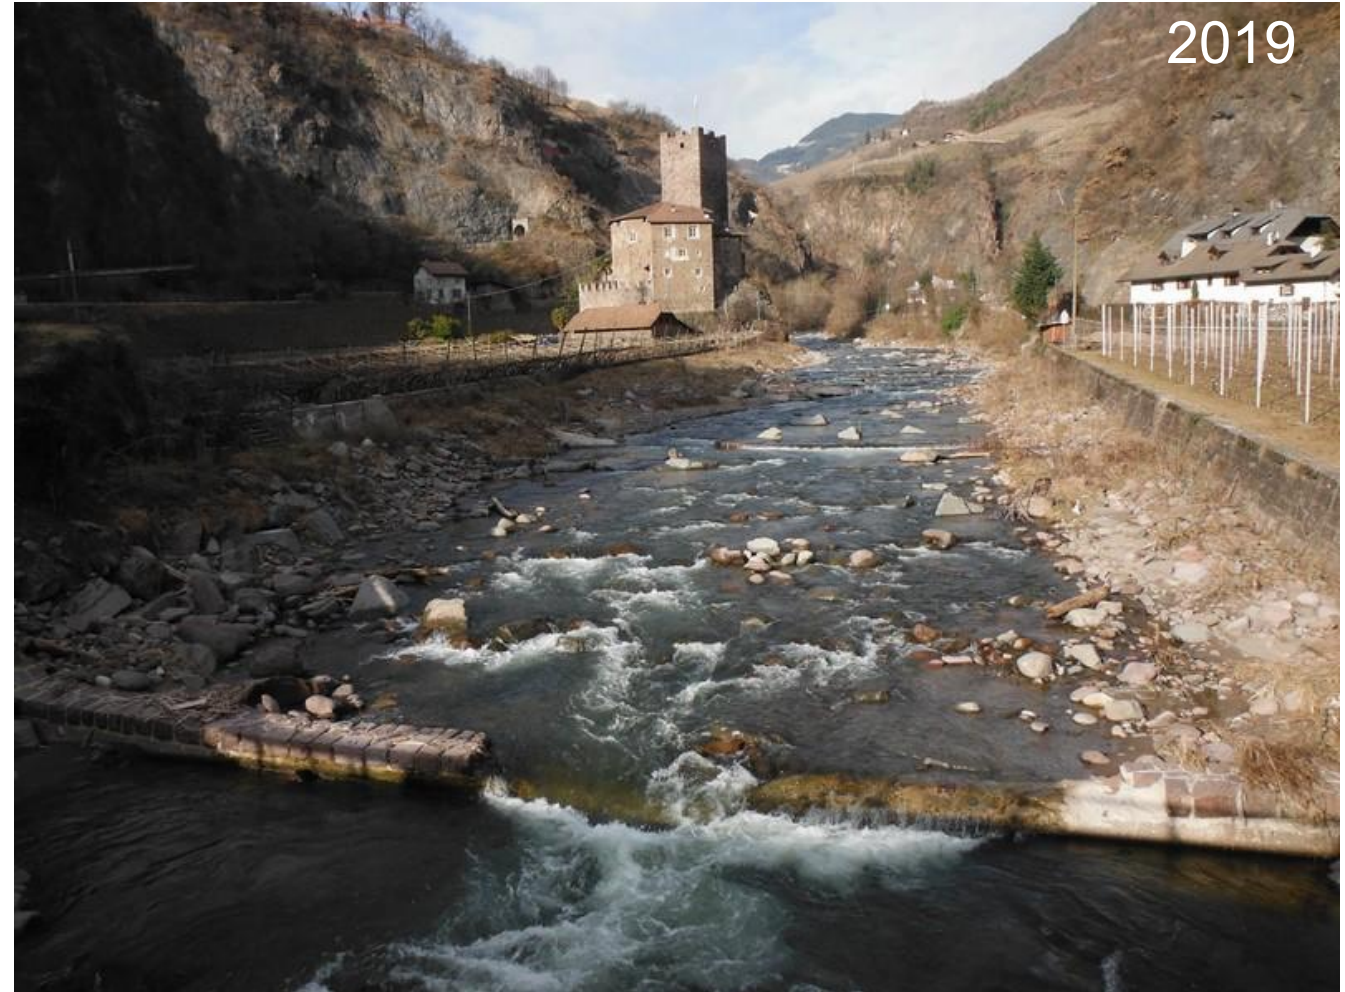
2019

**Goal: enhancing longitudinal continuity (for fish and sediment);
finding a balance between hydraulic risk management and river
restoration**

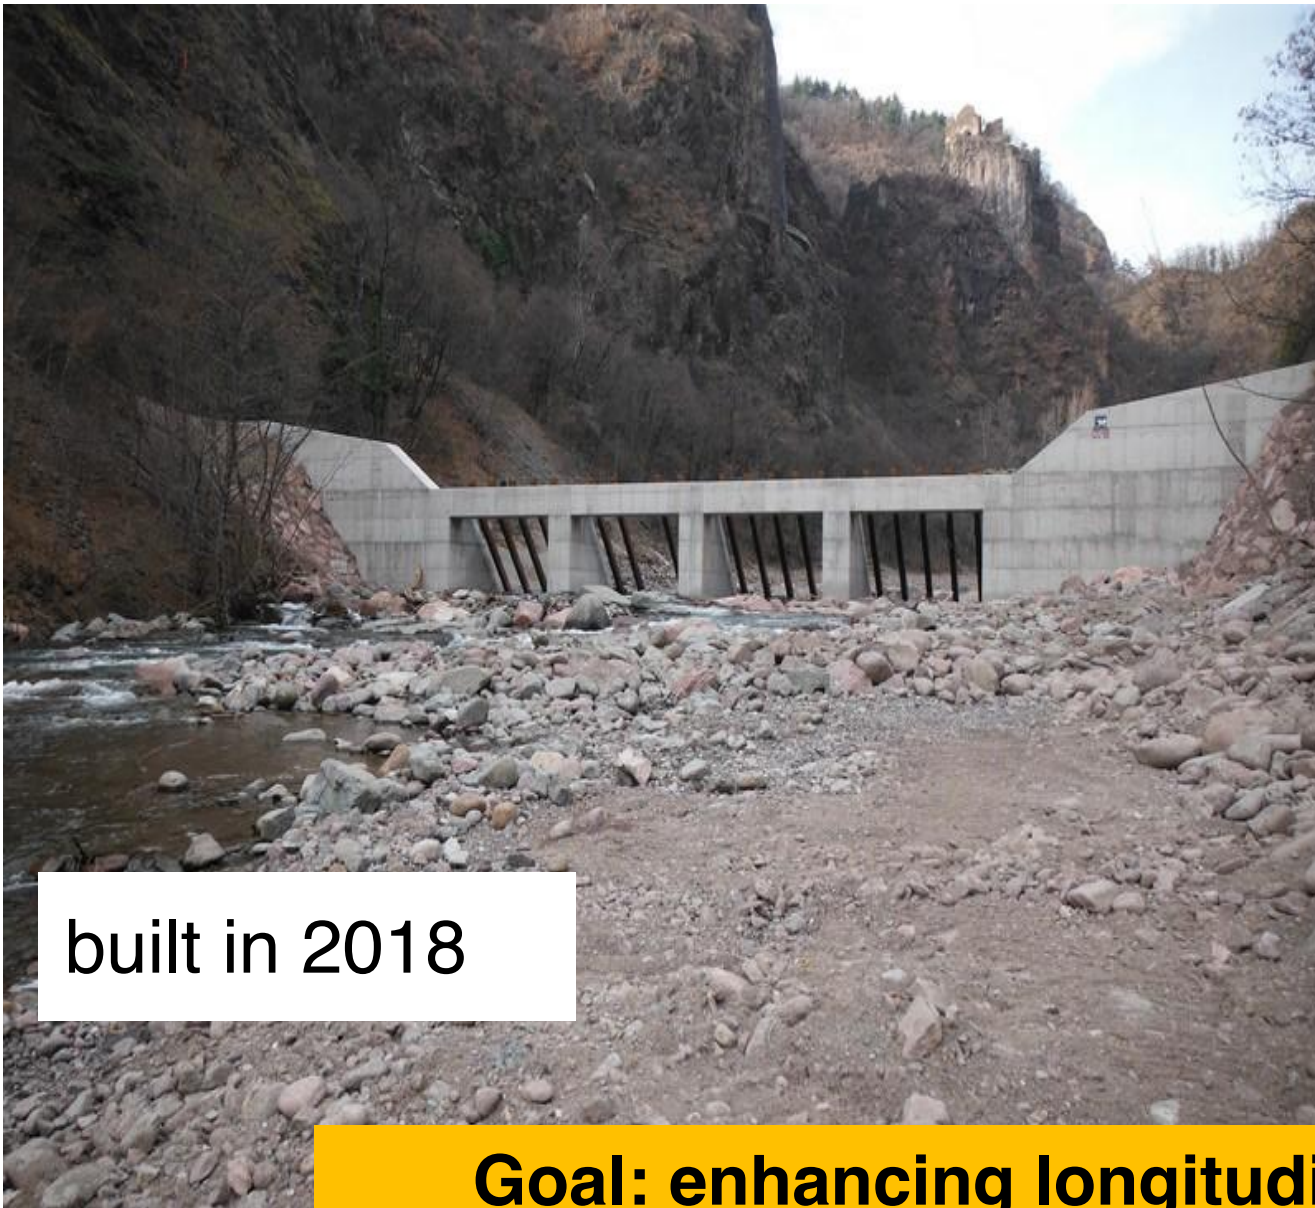
built in 2018

Retention check dam removal

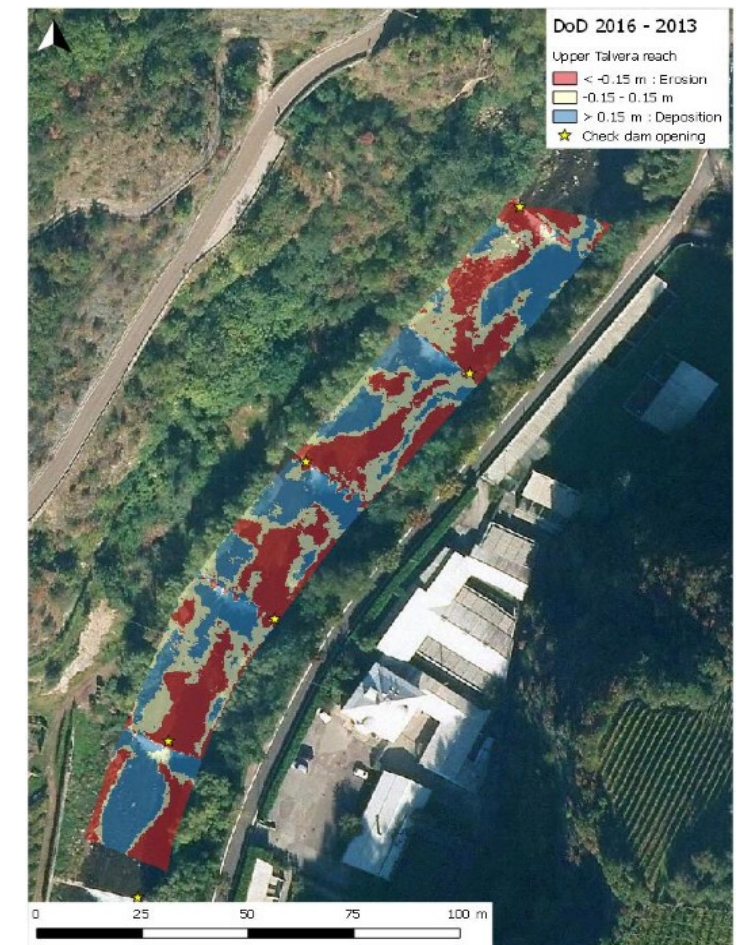
DoD 2018-2016

Results: along the main flow, induced by the check dam openings, erosion can be observed (red patterns), elsewhere deposition occurs (blue patterns)

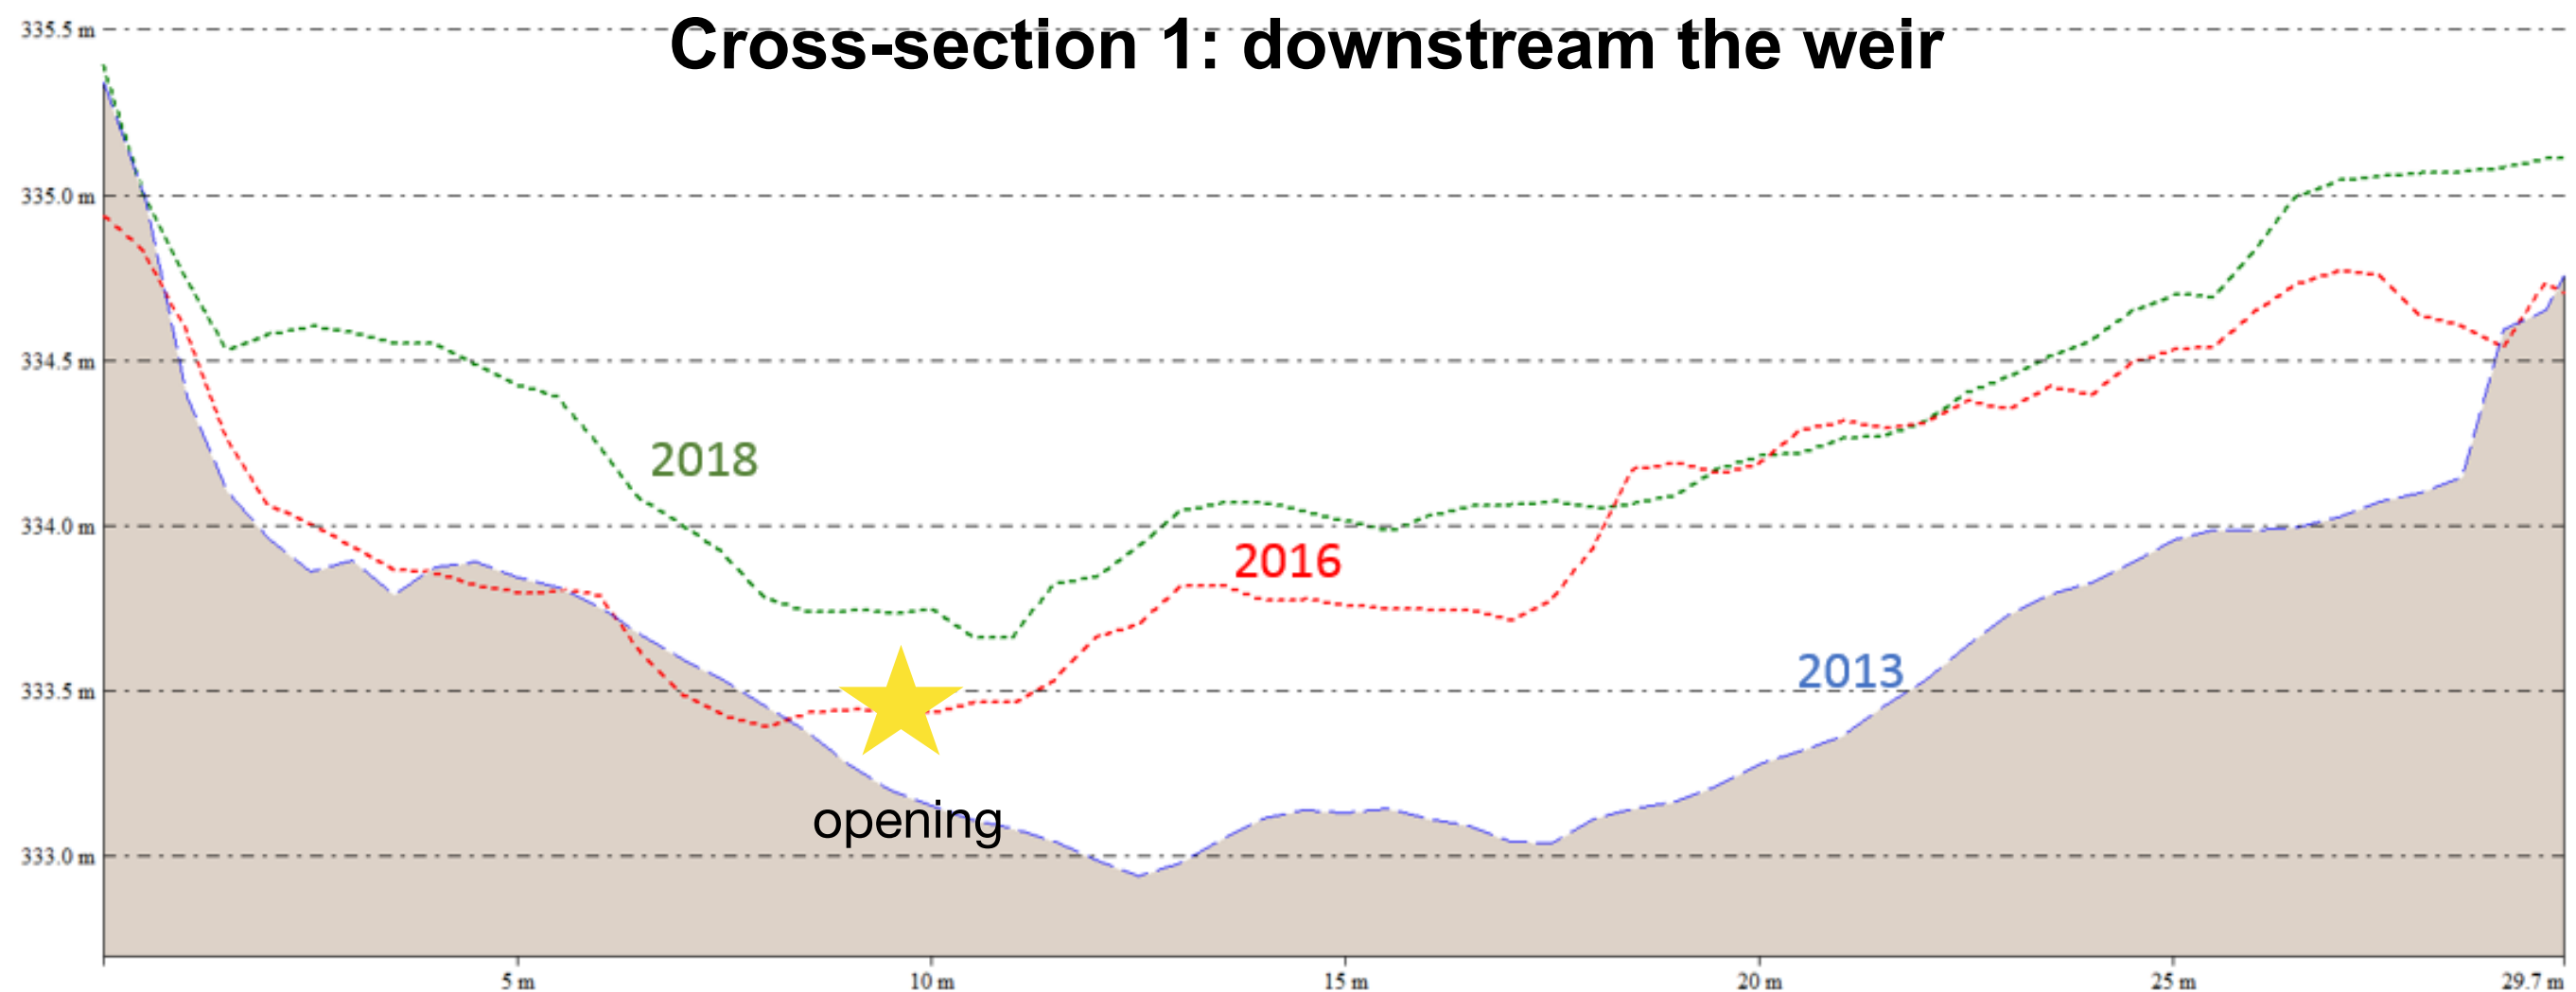
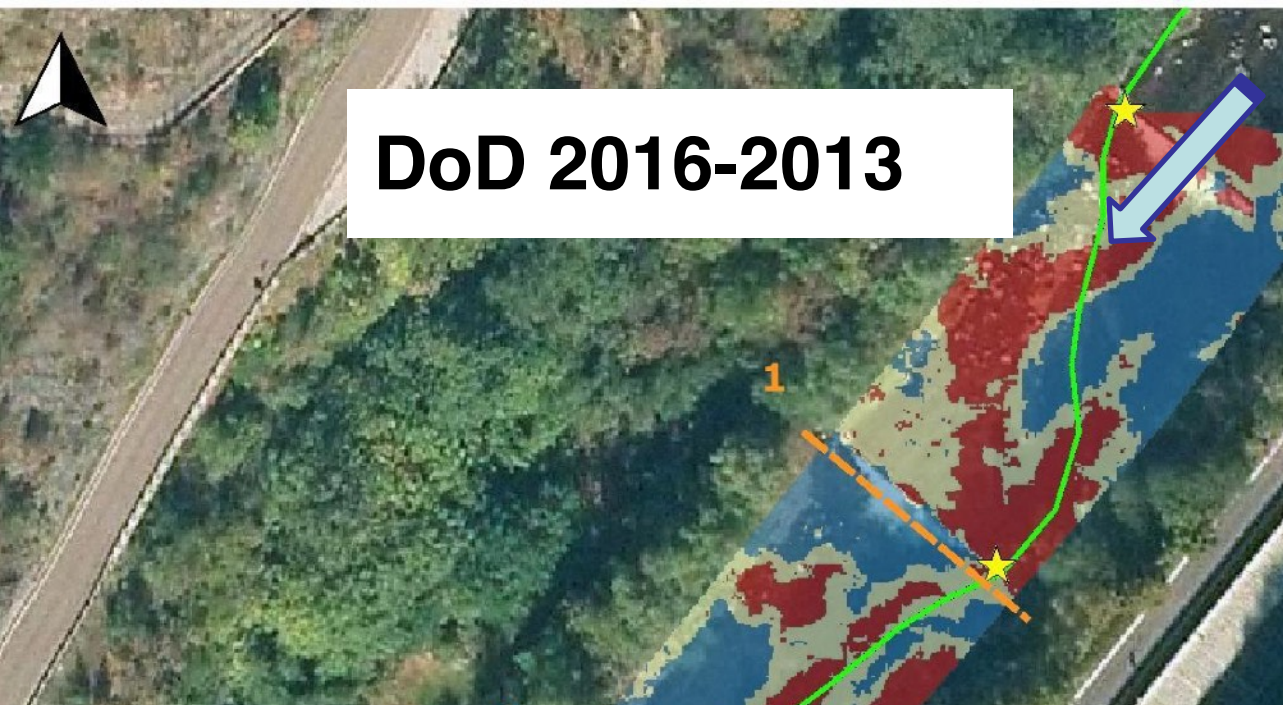
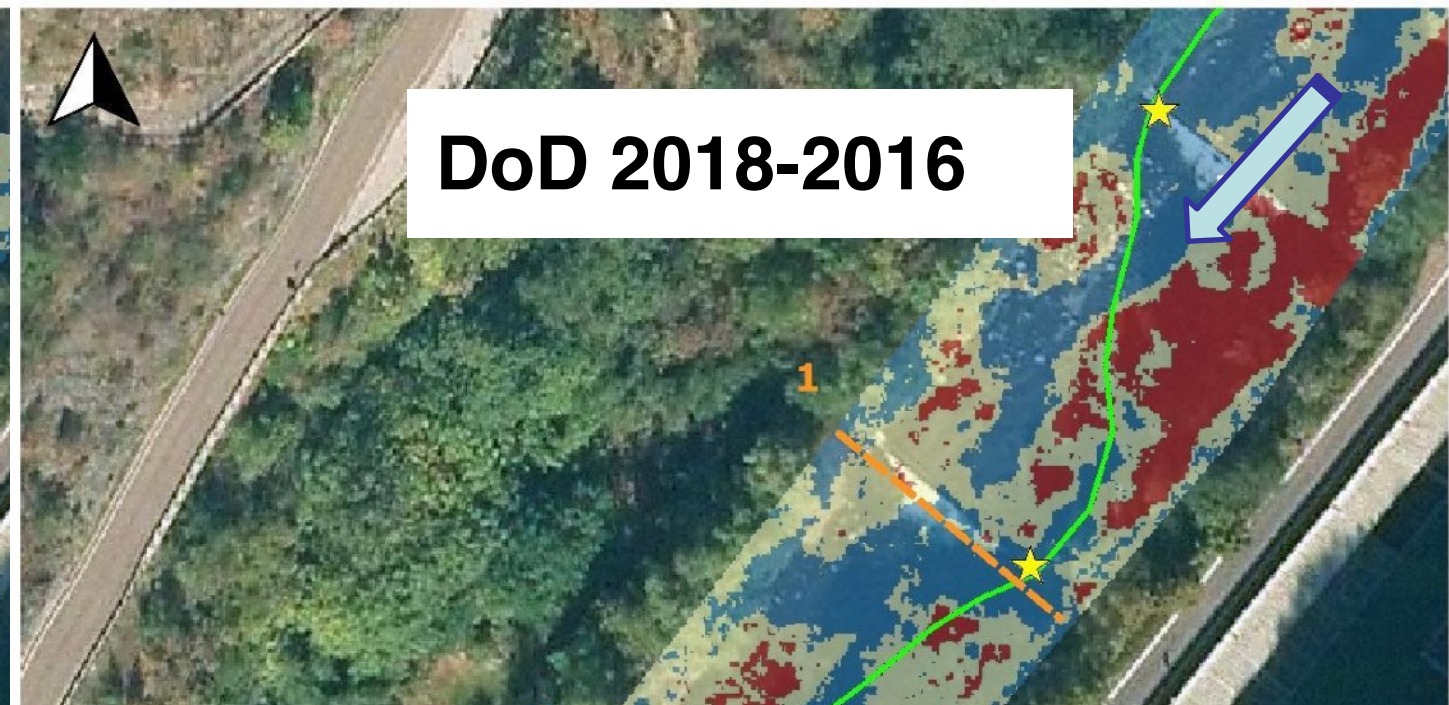
Cross-section 1: downstream the weir

From Pos: 681244.739, 5154771.002

To Pos: 681221.900, 5154790.035

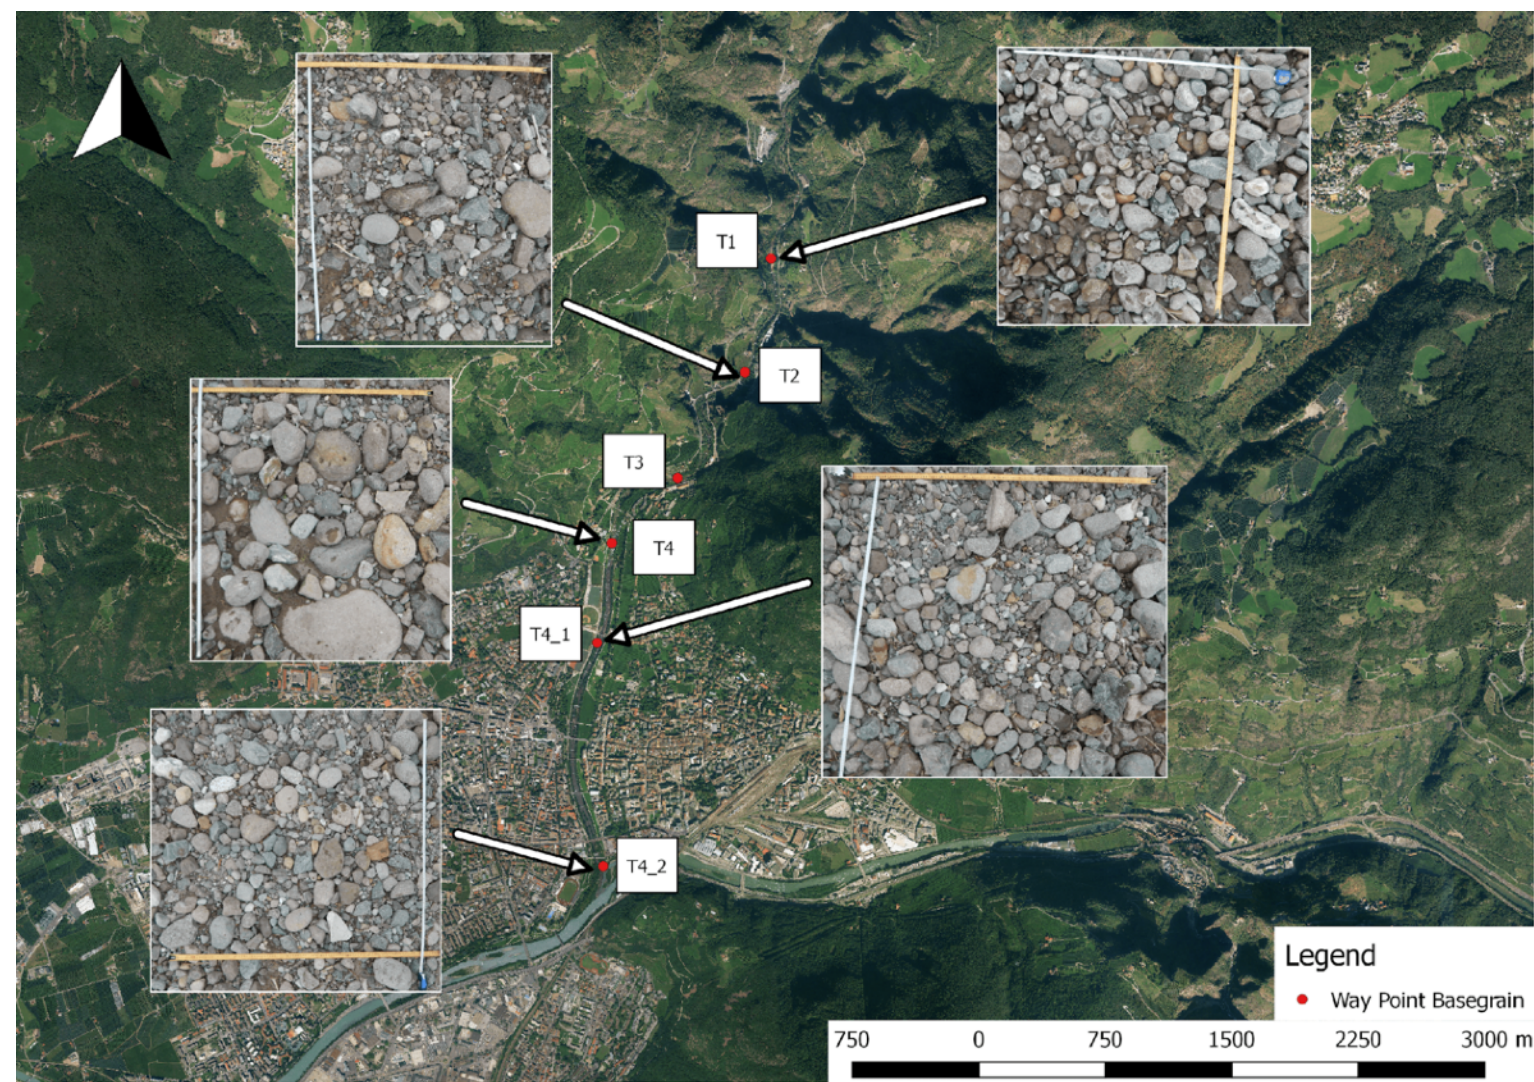
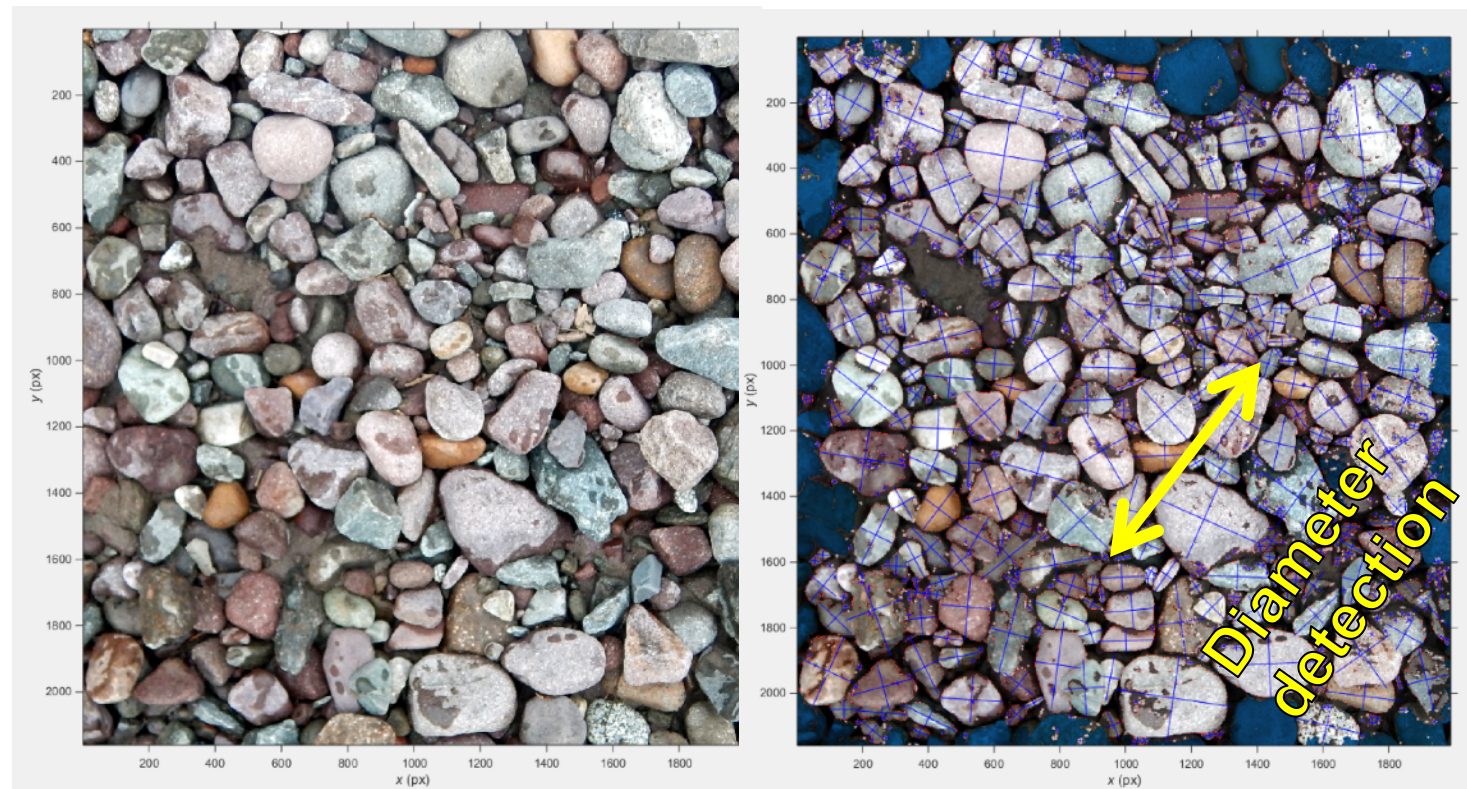
The restored reach has been divided into 6 sub-reaches

The surface sediments were analysed taking samples and using the software Basegrain and compared with previous studies (2013).

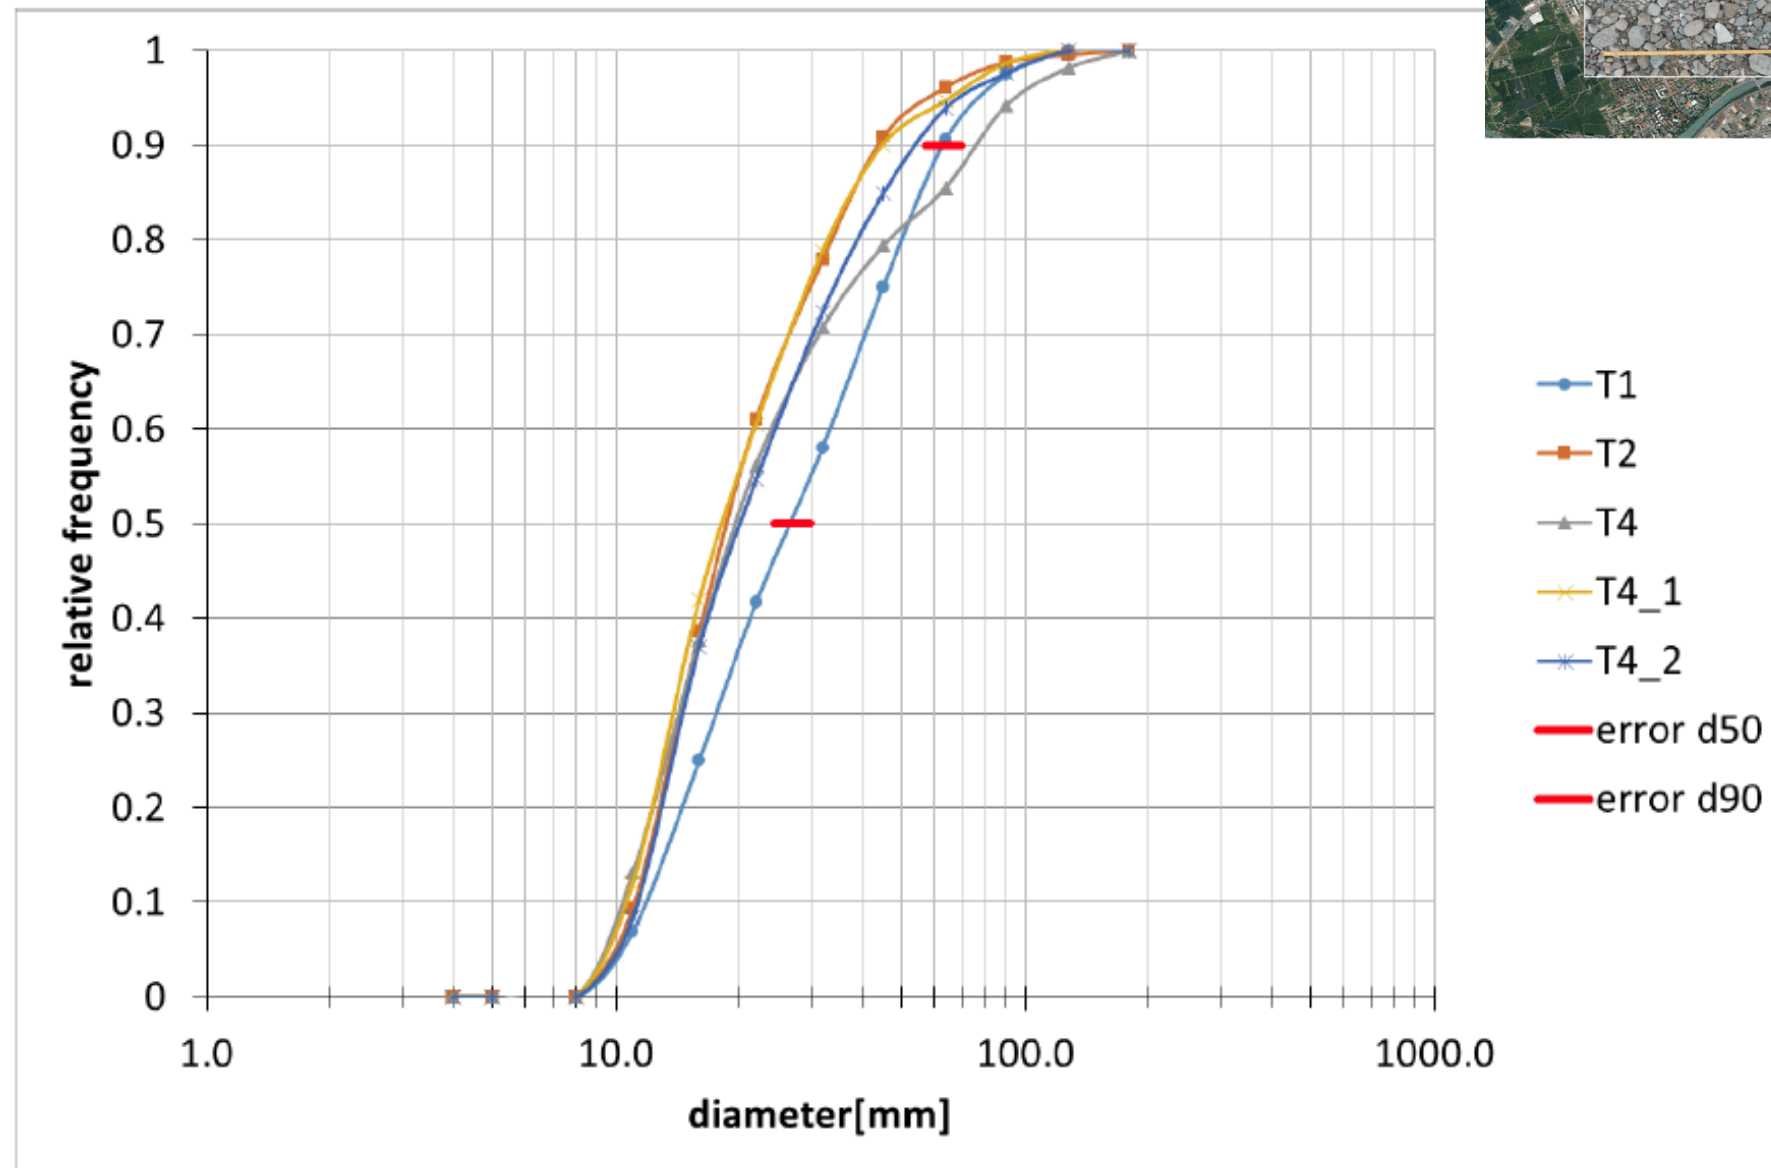
2019: Grain size distribution comparison among all survey points

T1: coarser grains compared to the other reaches

T2: same grain size as T4 (finer than T1)

T4: same grain size as T2 (finer than T1).
