Sediment transport along the Talferbach

the effectiveness of check dam openings in sediment continuity

Silvia Simoni - Mountain-eering S.r.l.

9th General Assembly - Bolzano May 2nd 2023

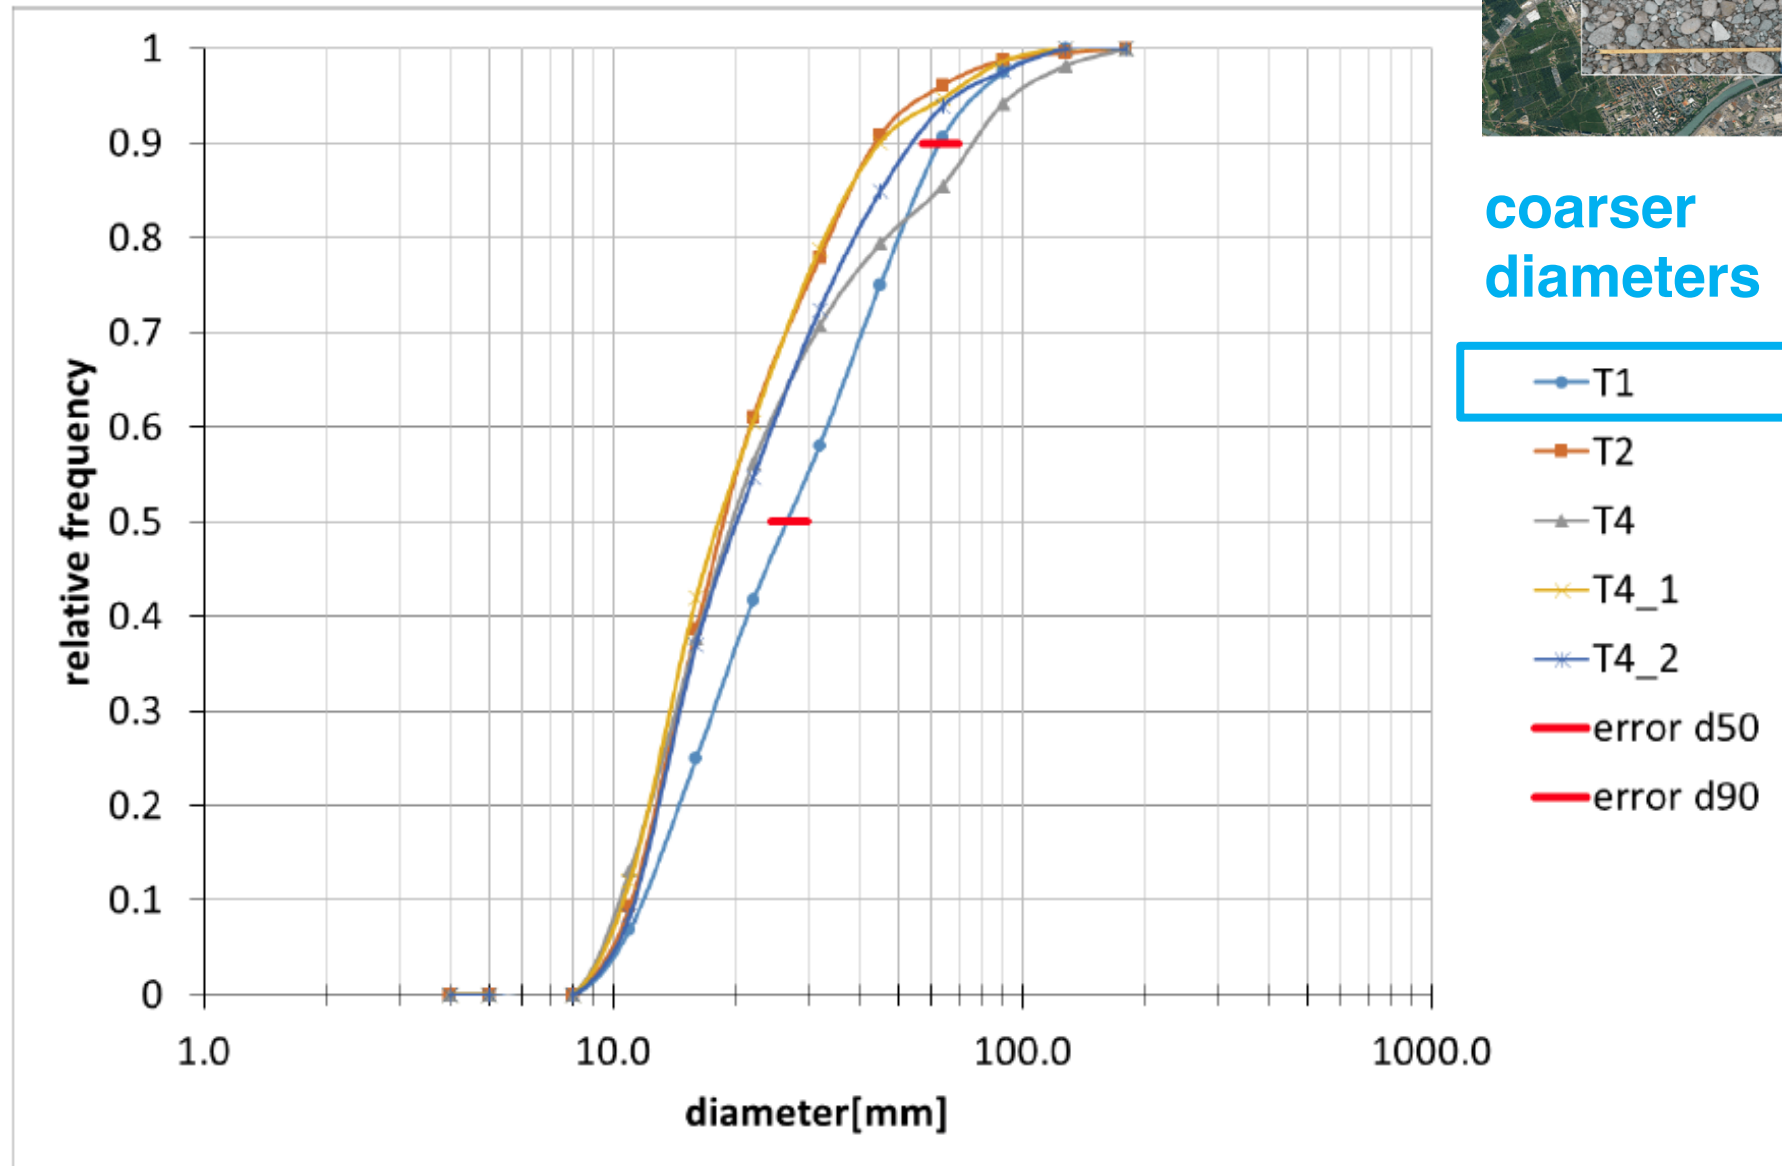
2019: Grain size distribution comparison among all survey points

T1: coarser grains compared to the other reaches

T2: same grain size as T4 (finer than T1)

T4: same grain size as T2 (finer than T1).
