Facts and findings on the 2021 floods in Limburg (NL)

Nathalie Asselman

23 June 2022

Watersystem evaluation

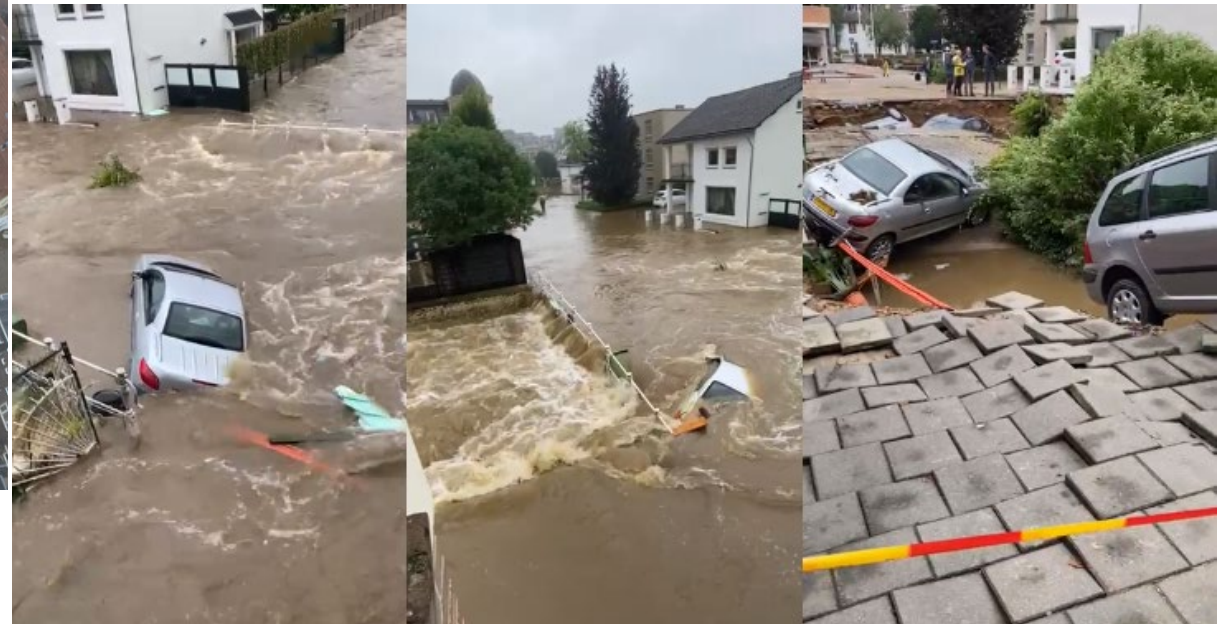
Flooding in Valkenburg

Water depths at many locations about 1,25 m

High flow velocities in some streets

Damage to buildings and bridges

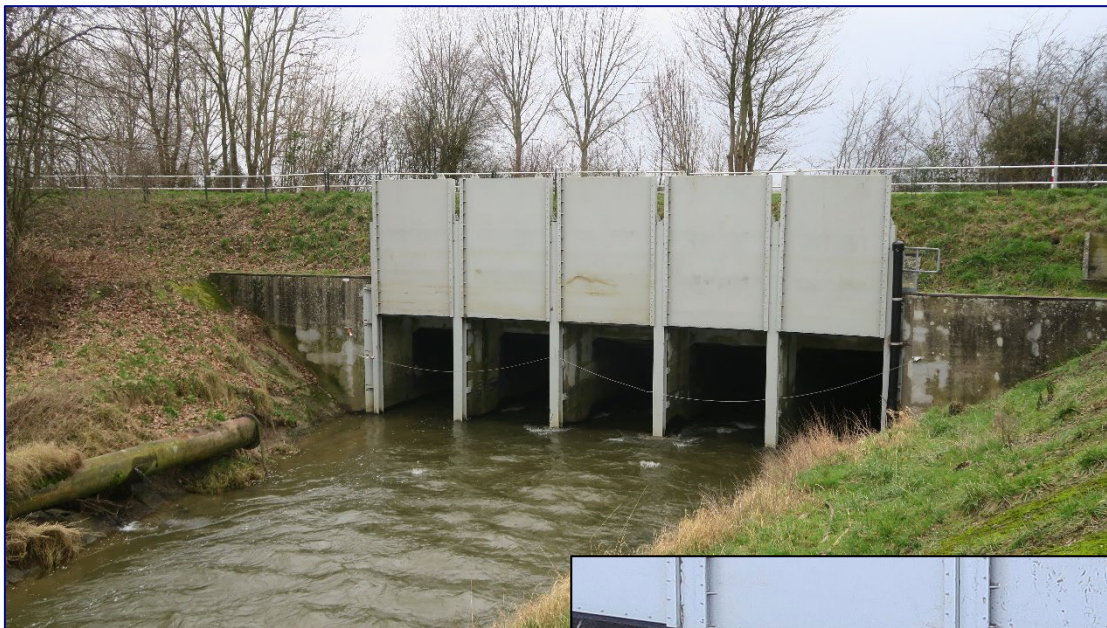
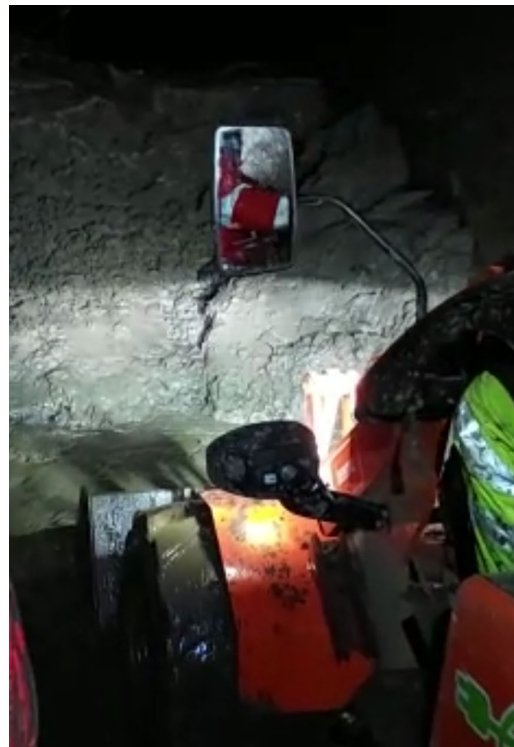
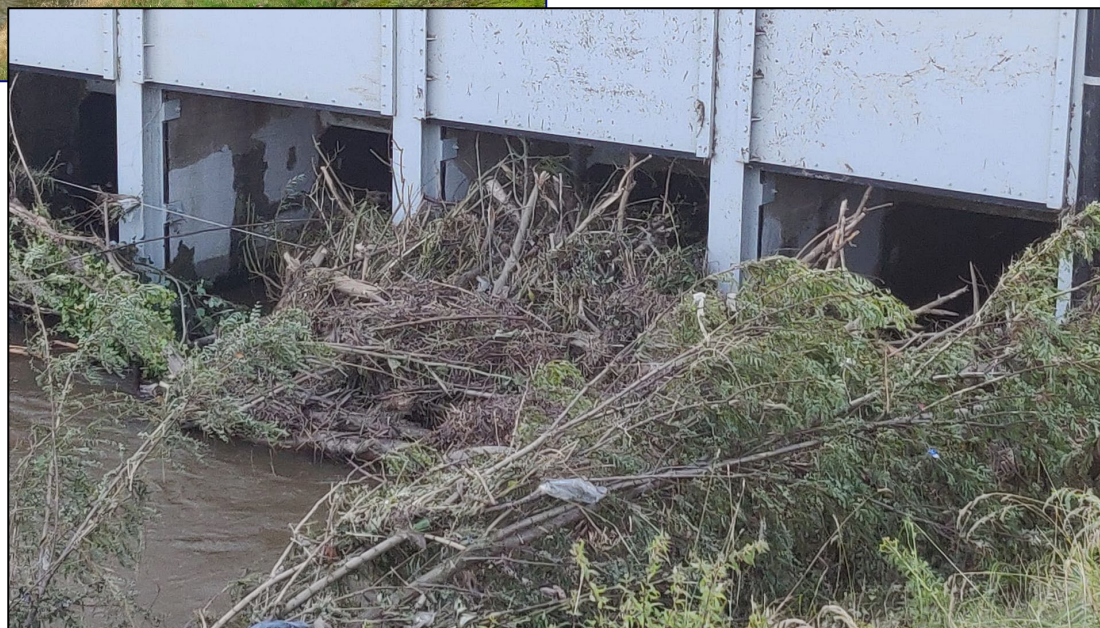
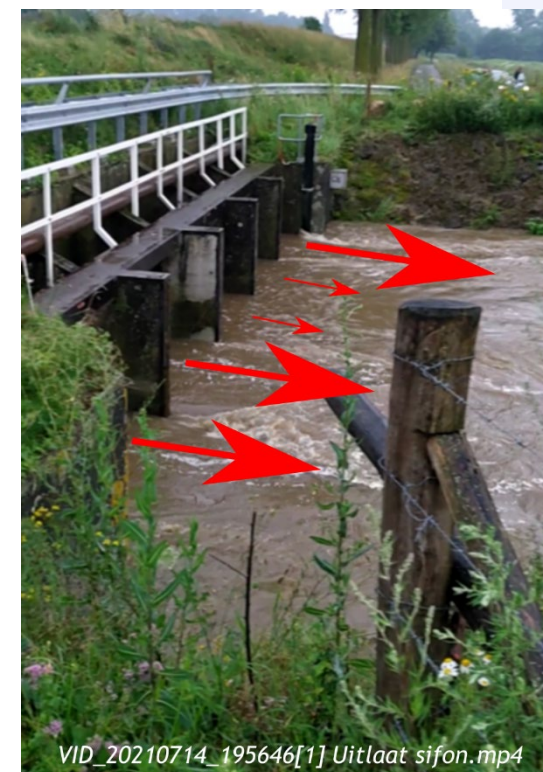
Confluence of Geul and Maas

- Peak discharge near Meerssen $\pm 110 \text{ m}^3/\text{s}$
- Capacity culvert low water levels Meuse $\pm 85 \text{ m}^3/\text{s}$
- Capacity culvert July (high water levels Meuse) $\pm 55 \text{ m}^3/\text{s}$
- Capacity may have been reduced further by blockage with driftwood or sediment

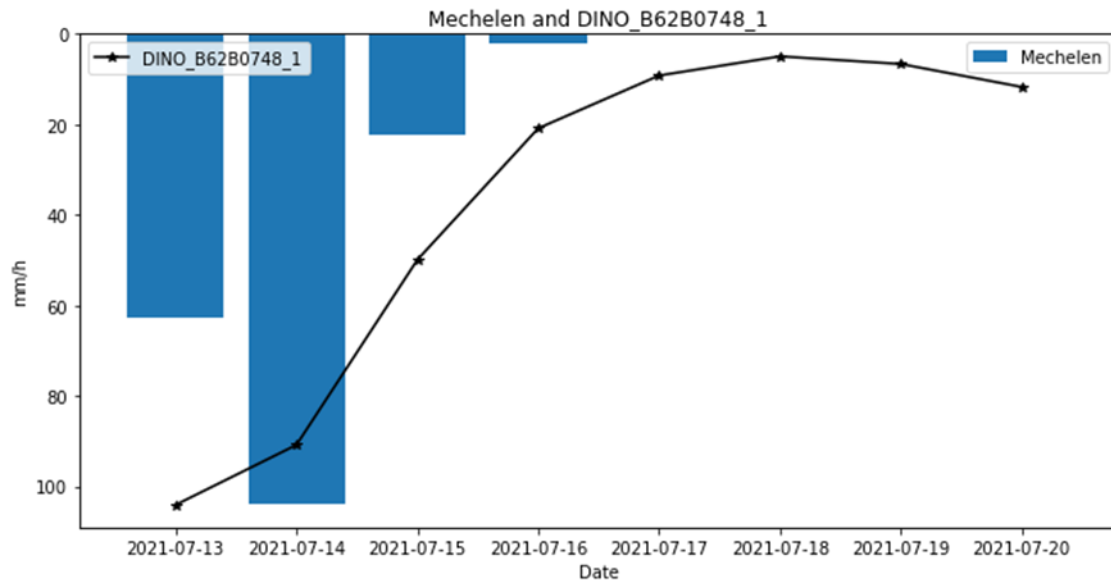
At the foot of a slope, N of Gulpen

Groundwater storage important in Geul catchment

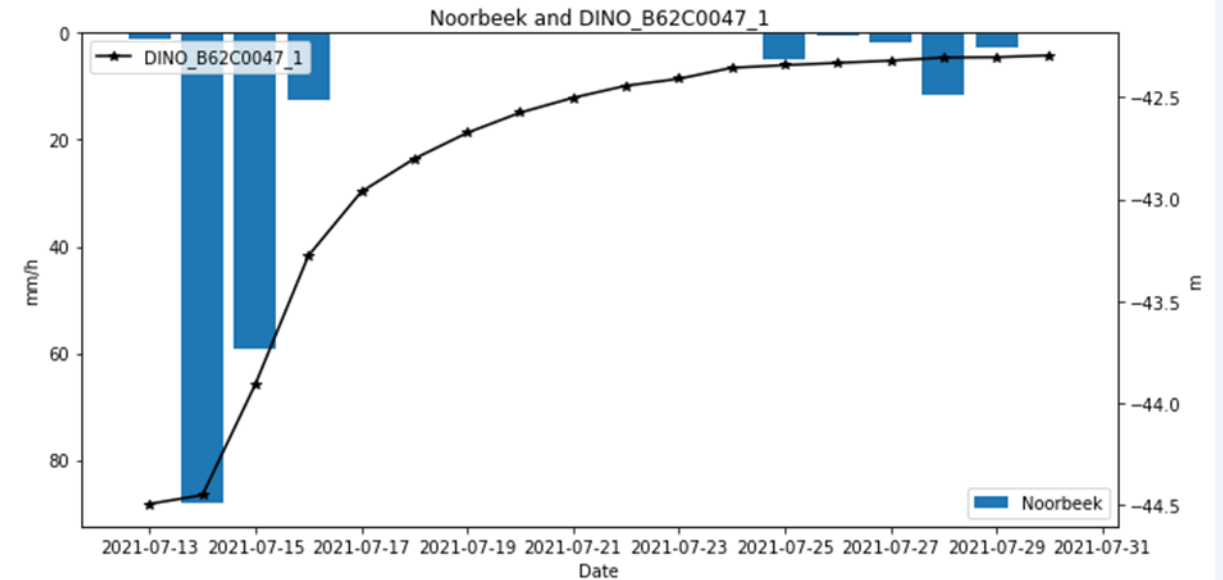
At plateau near Belgian border,
East of river Gulp (near Slenaken)

Similar patterns in northern part of Belgium
